**FOSTERS POND DAM**  
**FOLLOW-UP**  
**INSPECTION / EVALUATION REPORT**

Dam Name:	Fosters Pond Dam
State Dam ID#:	5-5-9-10
NID ID#:	MA00153
Owner:	Foster's Pond Corporation
Owner Type:	Private
Town:	Andover, Massachusetts
Consultant:	GEI Consultants, Inc.
Date of Inspection:	May 8, 2008

**Re: Dam Follow-up Inspection  
Fosters Pond Dam, NID # MA00153  
Andover, Massachusetts**

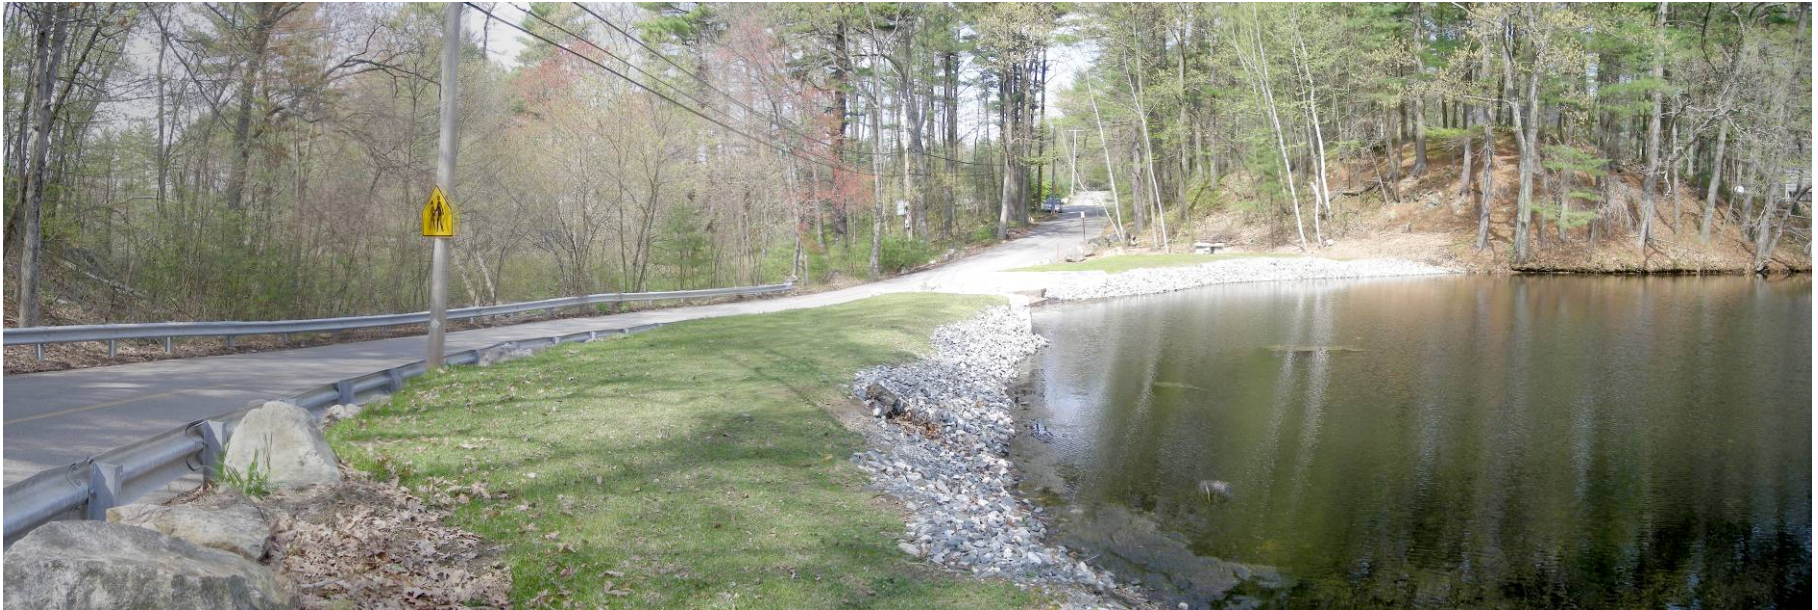
Photo 1 – Panoramic composite - Upstream slope and crest from left\*

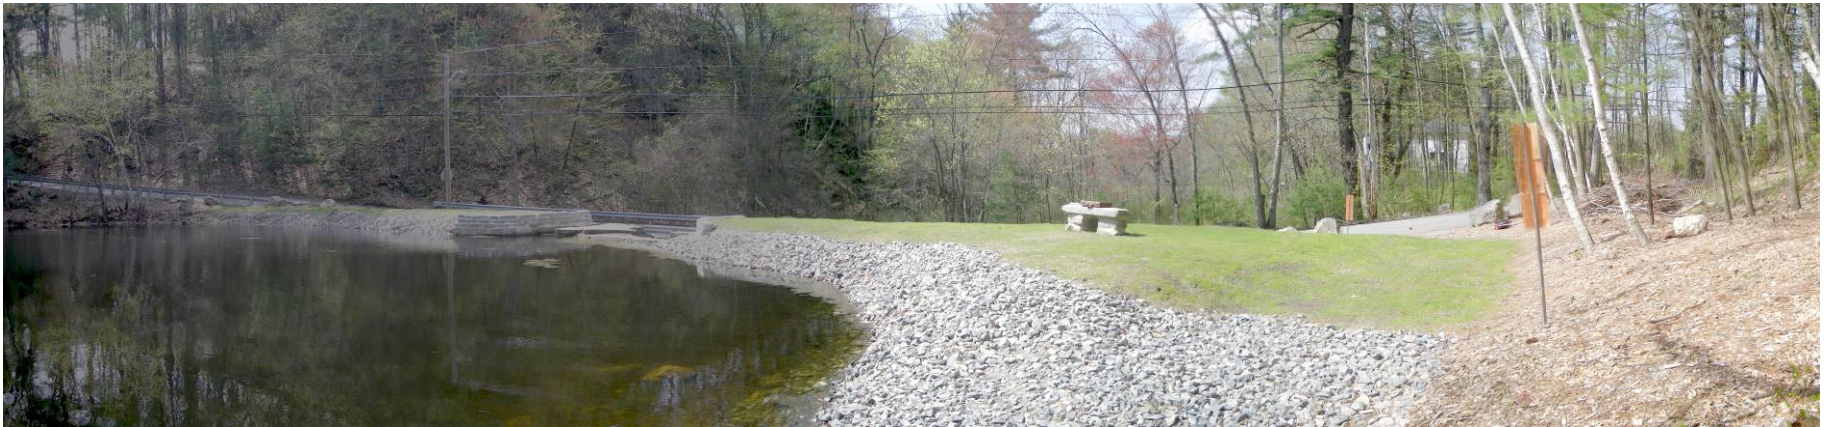
Photo 2 – Panoramic composite - Upstream slope and crest from right\*

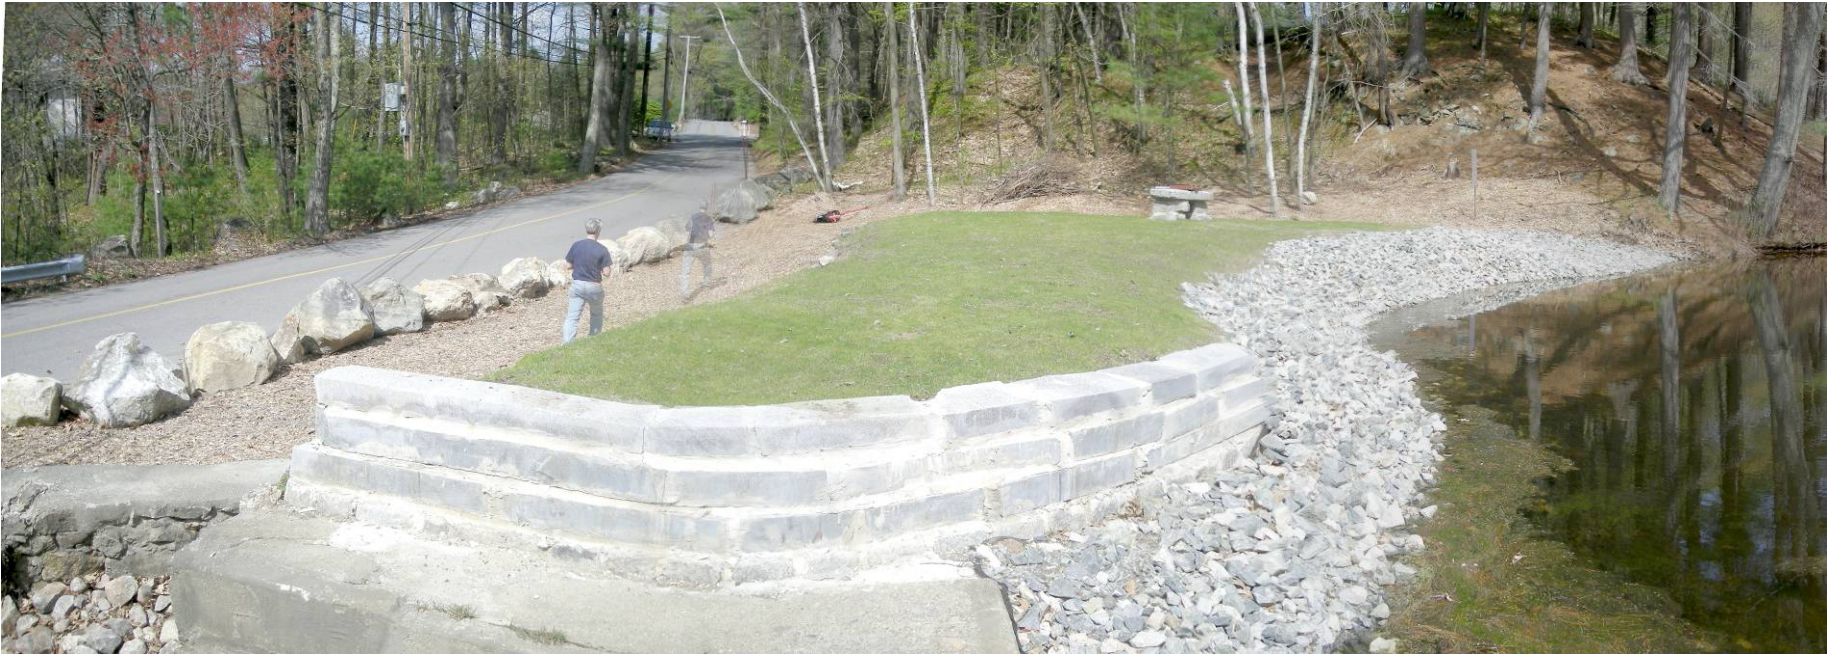
Photo 3 – Panoramic composite – Right abutment and crest\*

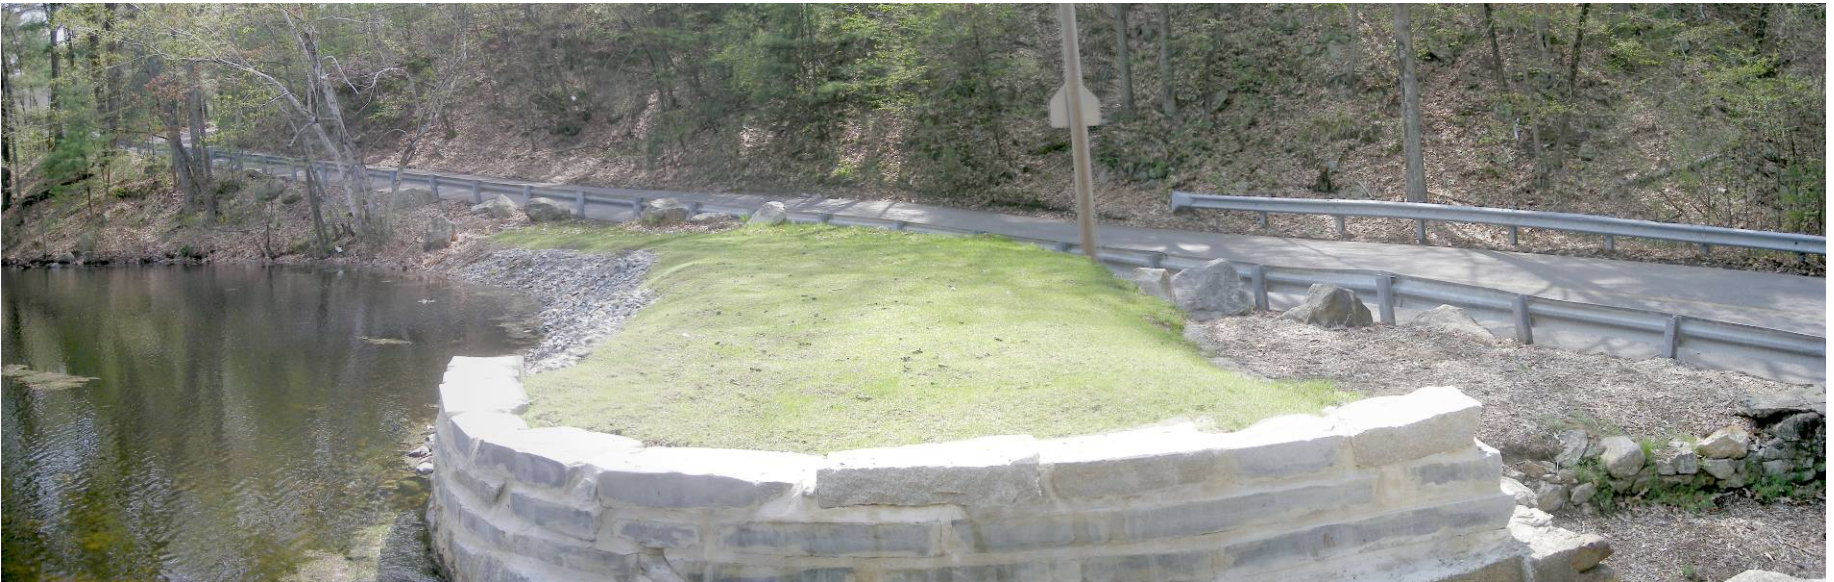
Photo 4 – Panoramic composite – Left abutment and crest\*

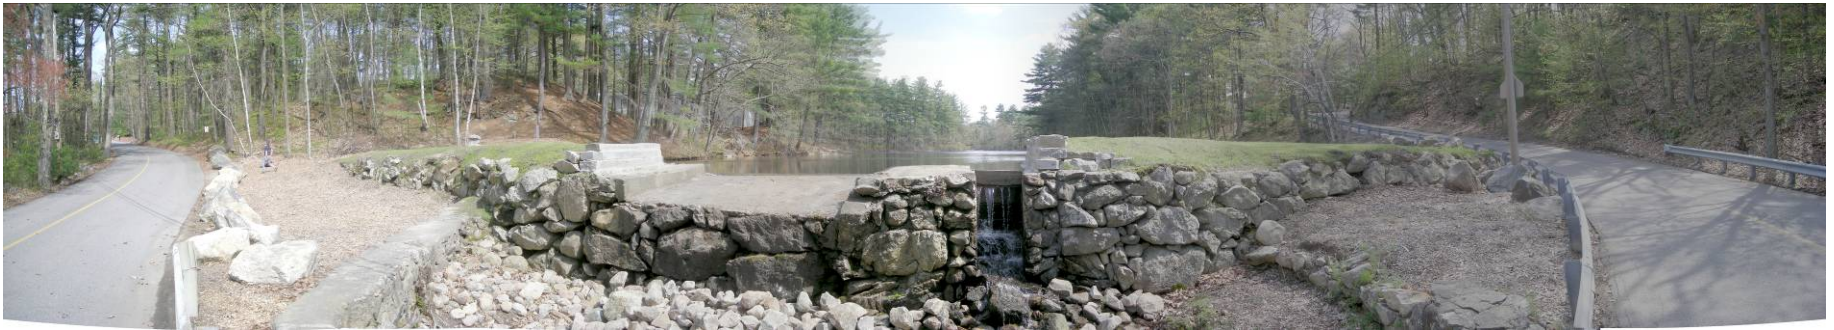
- Seepage is observed at the base of the downstream unmortared masonry wall below the main spillway.

Photo 5 – Panoramic composite – Downstream face, spillway, and sluiceway from downstream\*

- Monitor seepage for changing conditions and new locations downstream of the dam and development of sinkholes within the embankment.

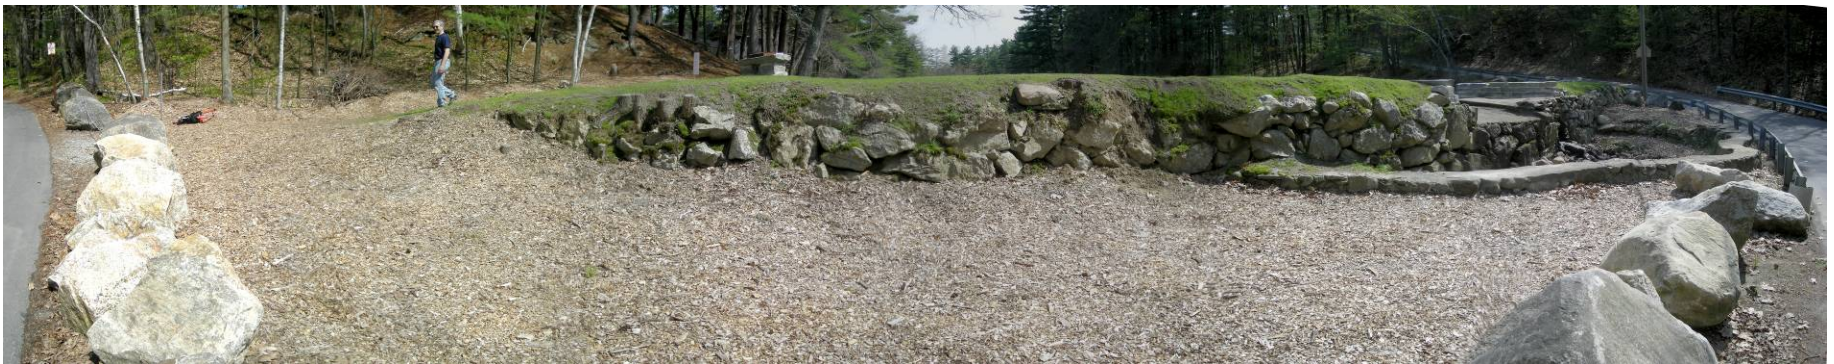
Photo 6 – Panoramic composite – Right downstream face from downstream\*

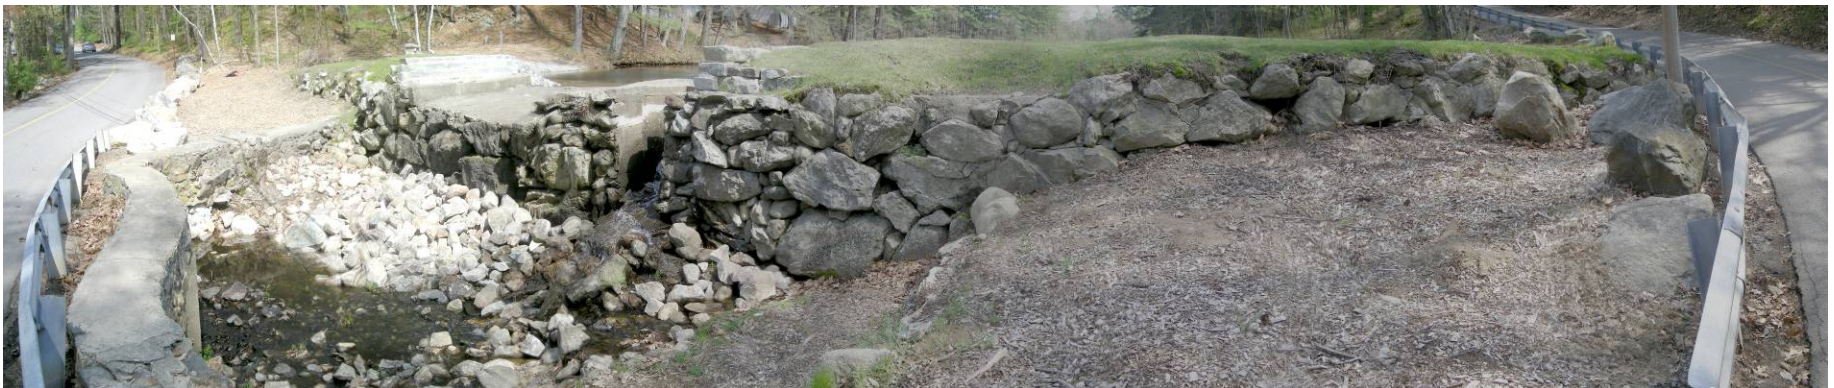
Photo 7 – Panoramic composite – Left downstream face, spillway, and plunge pool from downstream\*

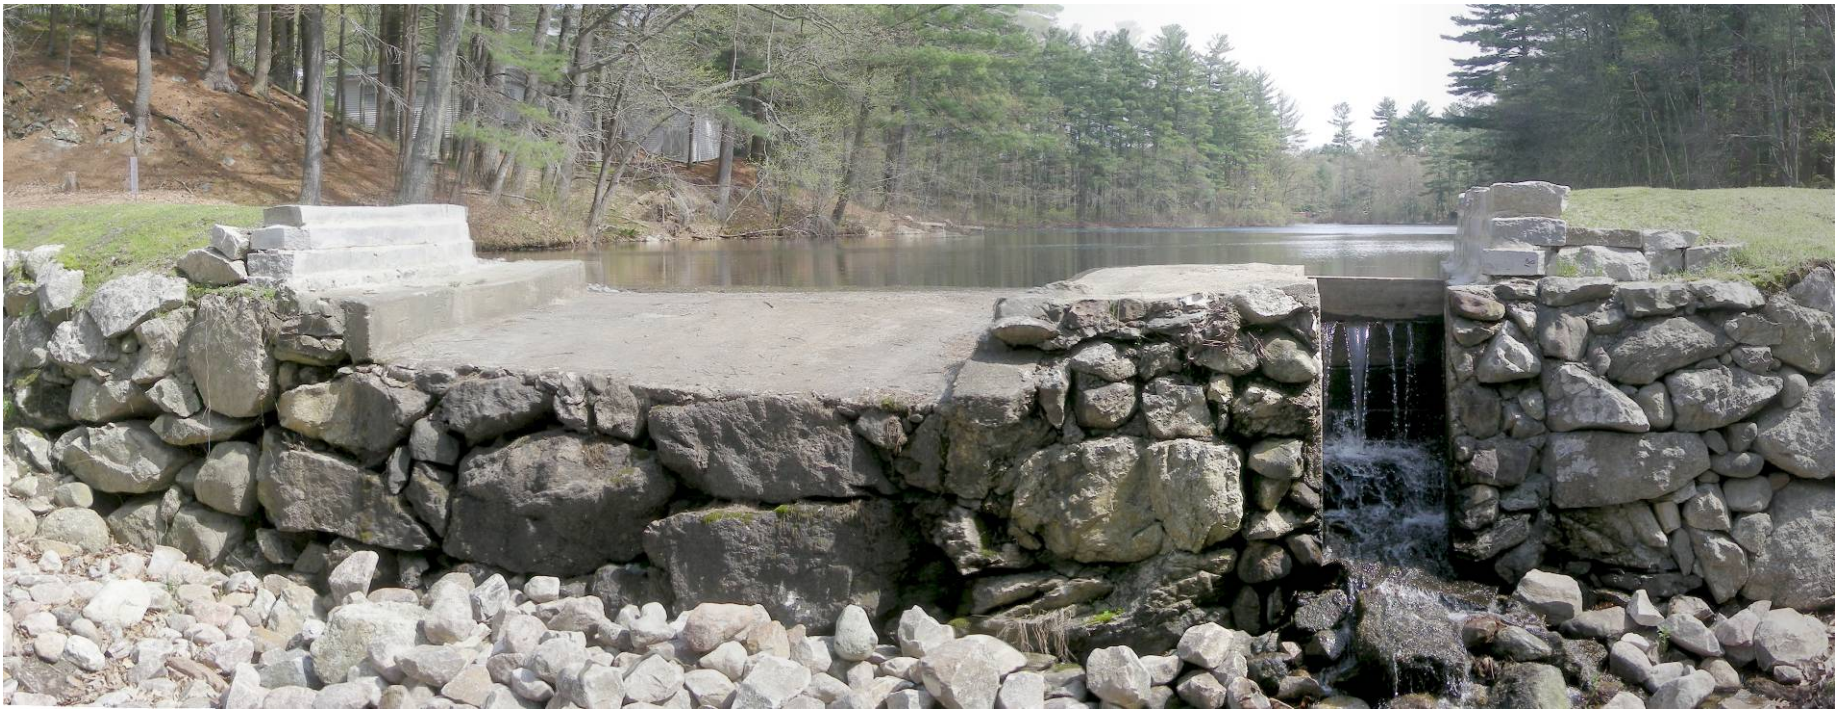
Photo 8 – Panoramic composite – Spillway, sluiceway, and plunge pool from downstream\*

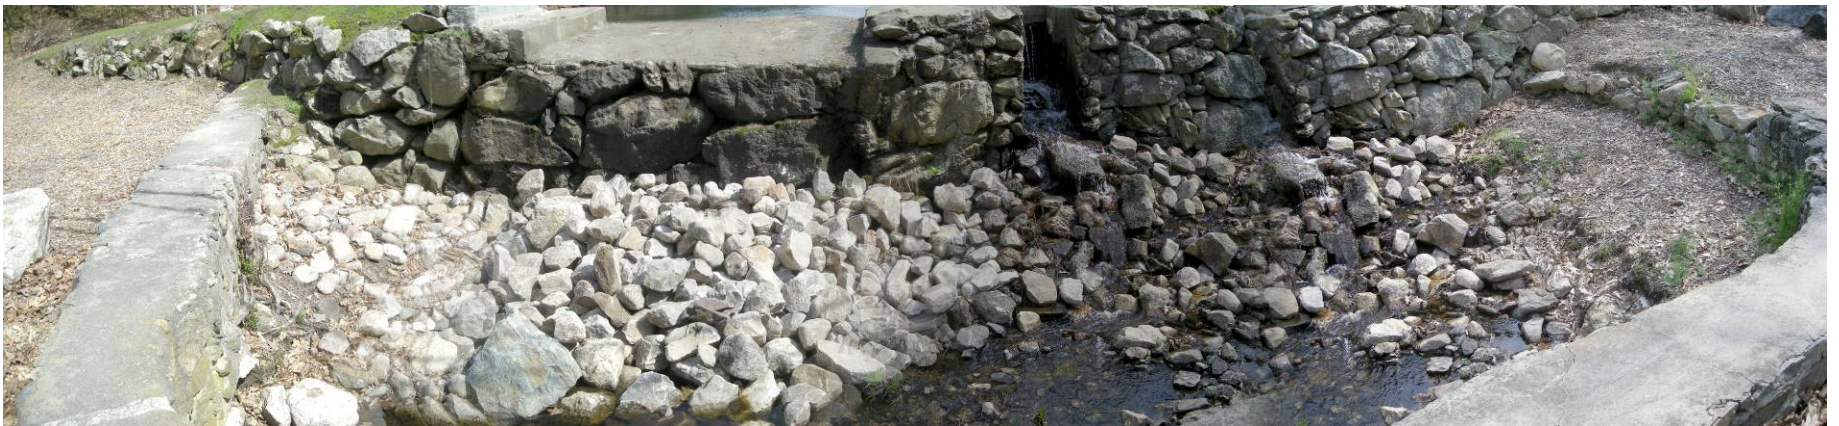
Photo 9 – Panoramic composite – Plunge pool from downstream\*

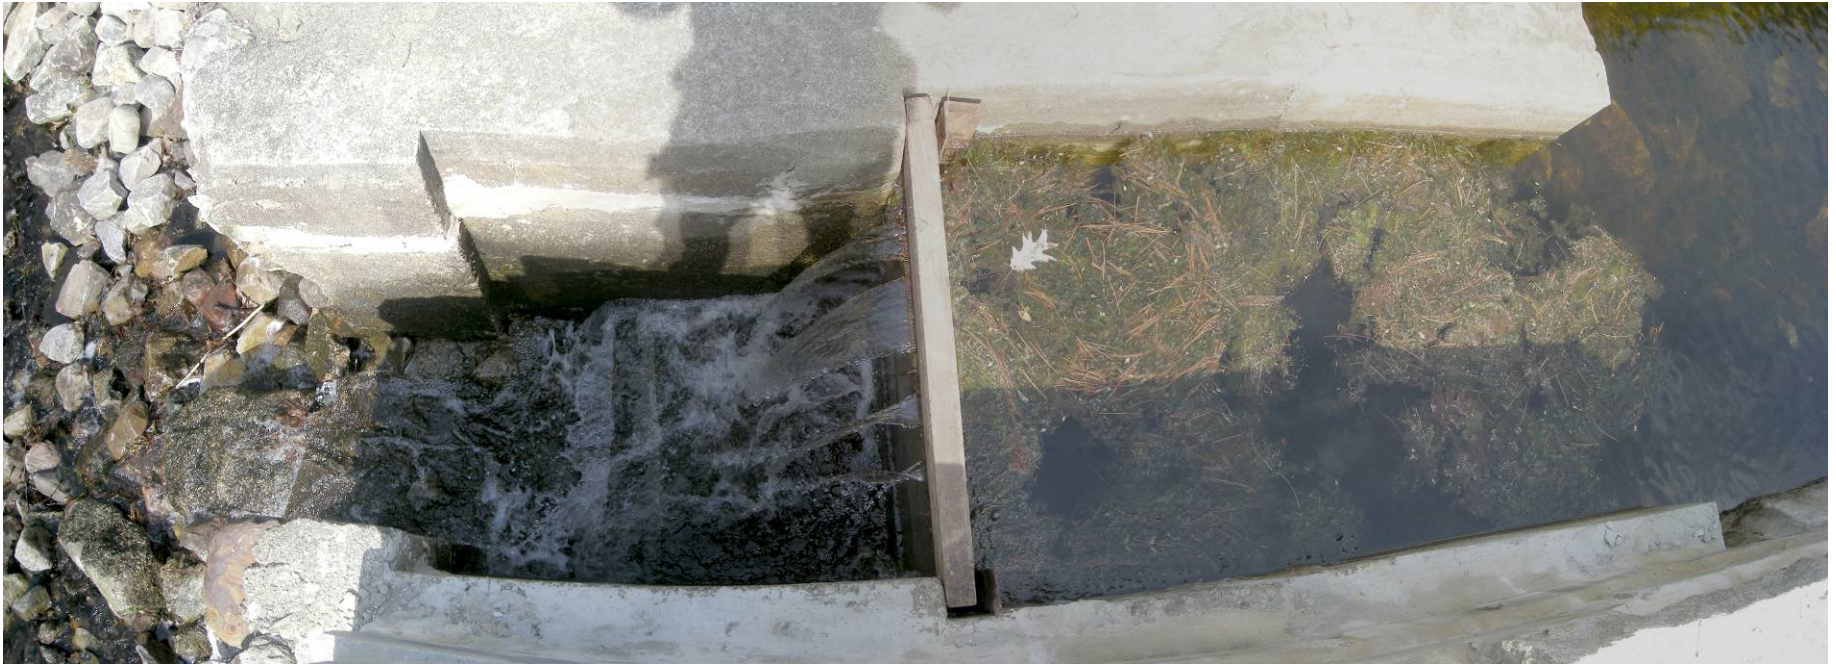
Photo 10 – Panoramic composite – Sluiceway from above\*

ADDITIONAL COMMENTS: <u>1. Condition of concrete good. No cracks observed. See photo 10. Sluiceway repaired in the fall of 2005 to accommodate stoplogs and lowering of the water in the winter months.</u>

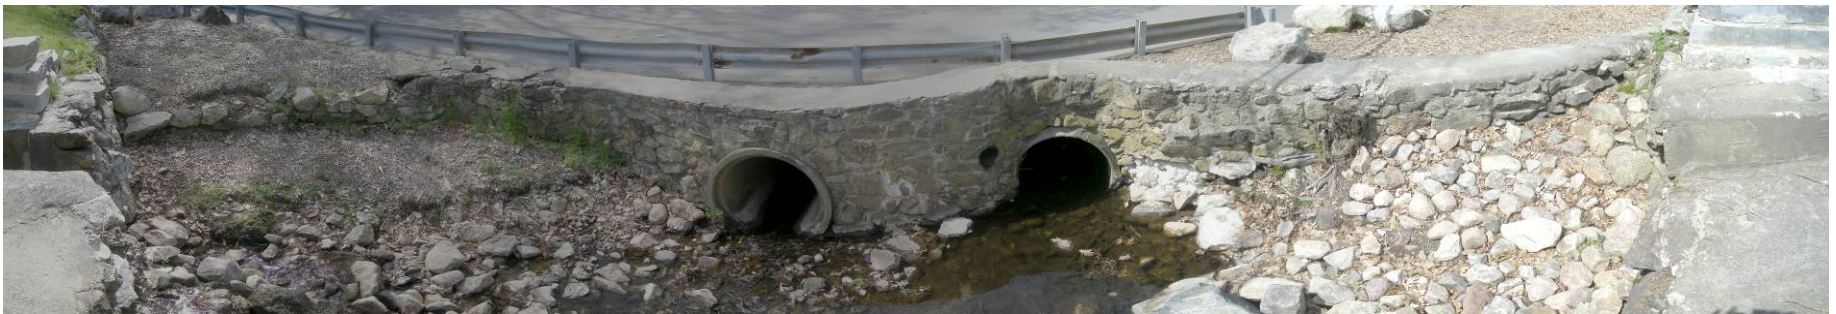
Photo 11 – Panoramic composite – Downstream part of plunge pool and culverts under Rattlesnake Hill Road, from spillway\*

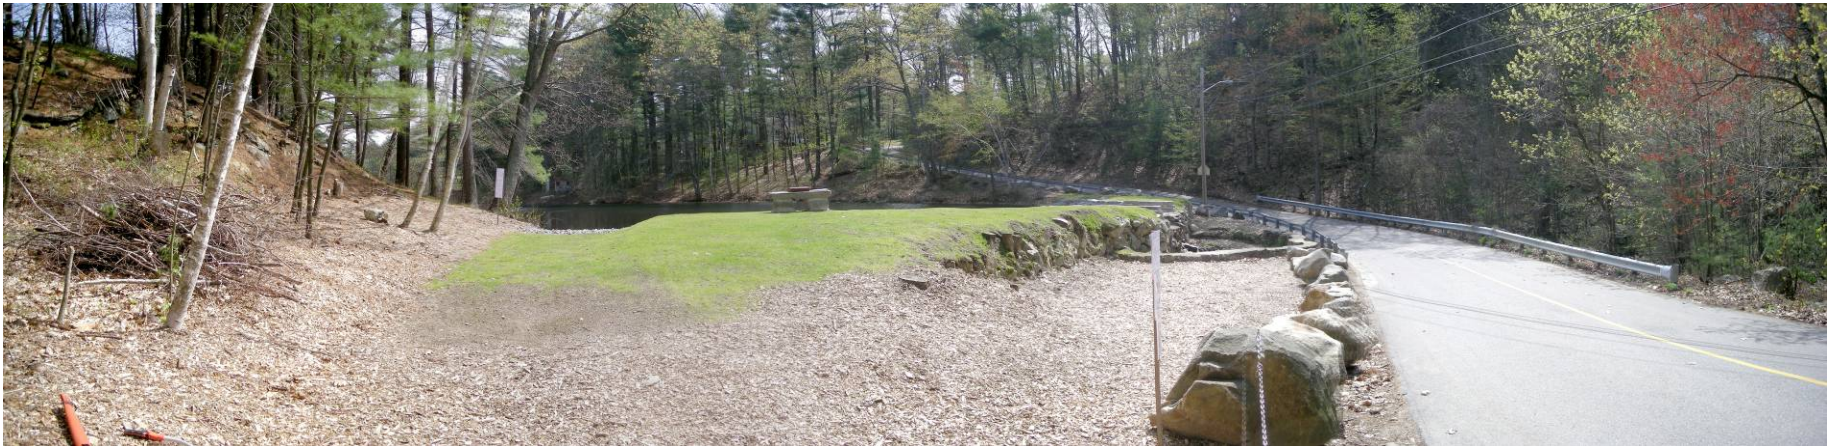
Photo 12 – Panoramic composite – Emergency spillway and dam from right downstream side\*

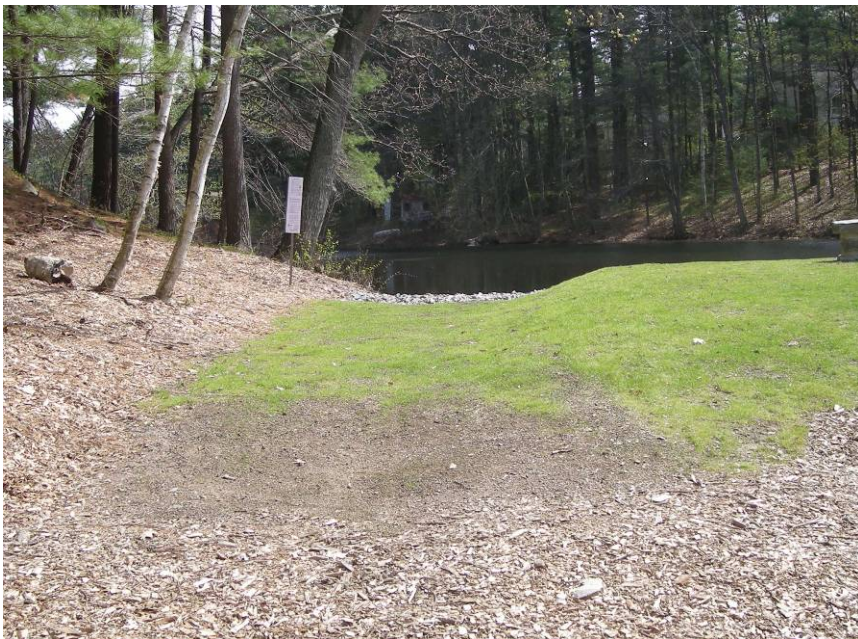
Photo 13 – Emergency spillway from downstream

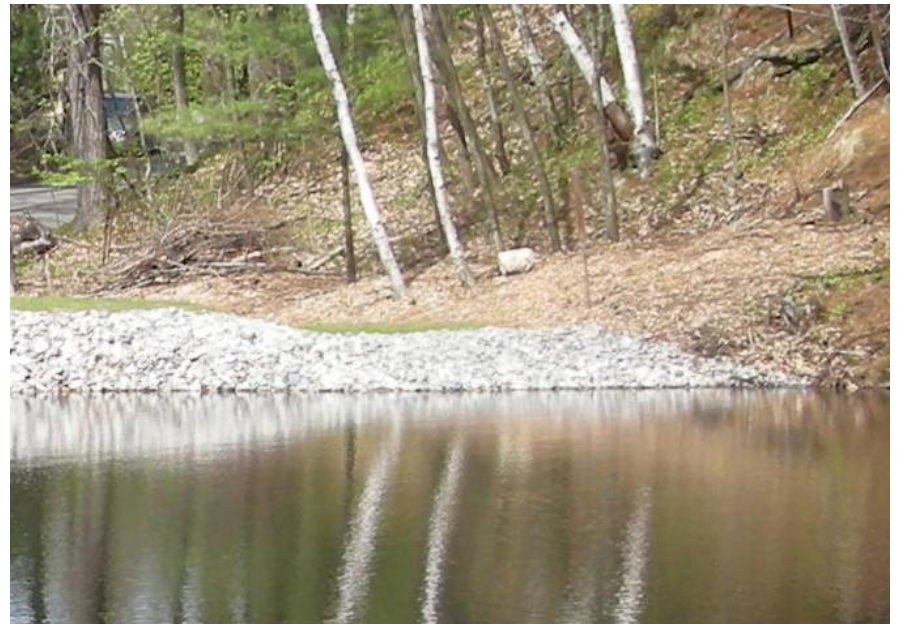
Photo 14 – Emergency spillway from upstream

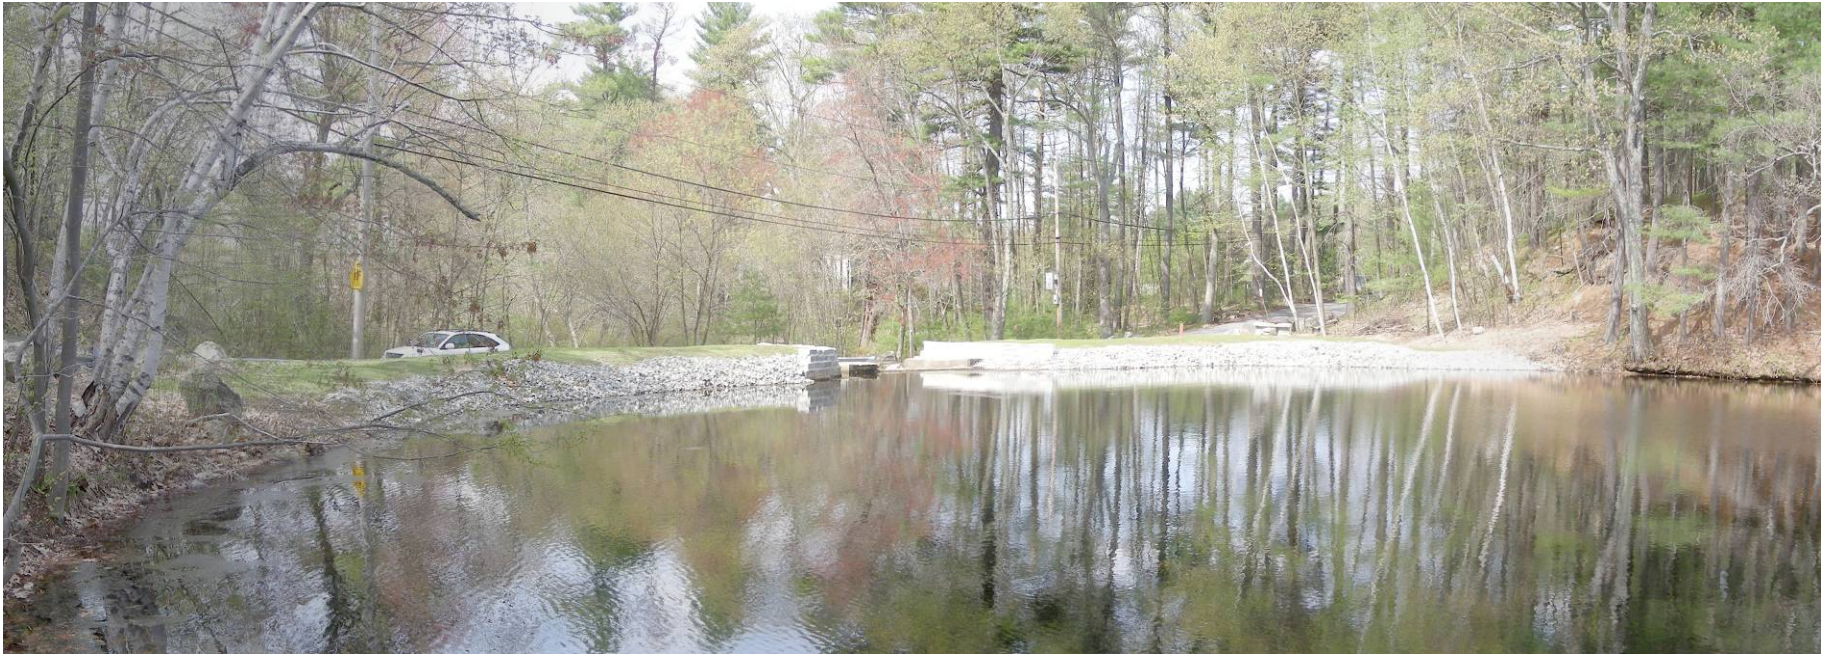
Photo 15 – Panoramic composite – Upstream side of dam\*

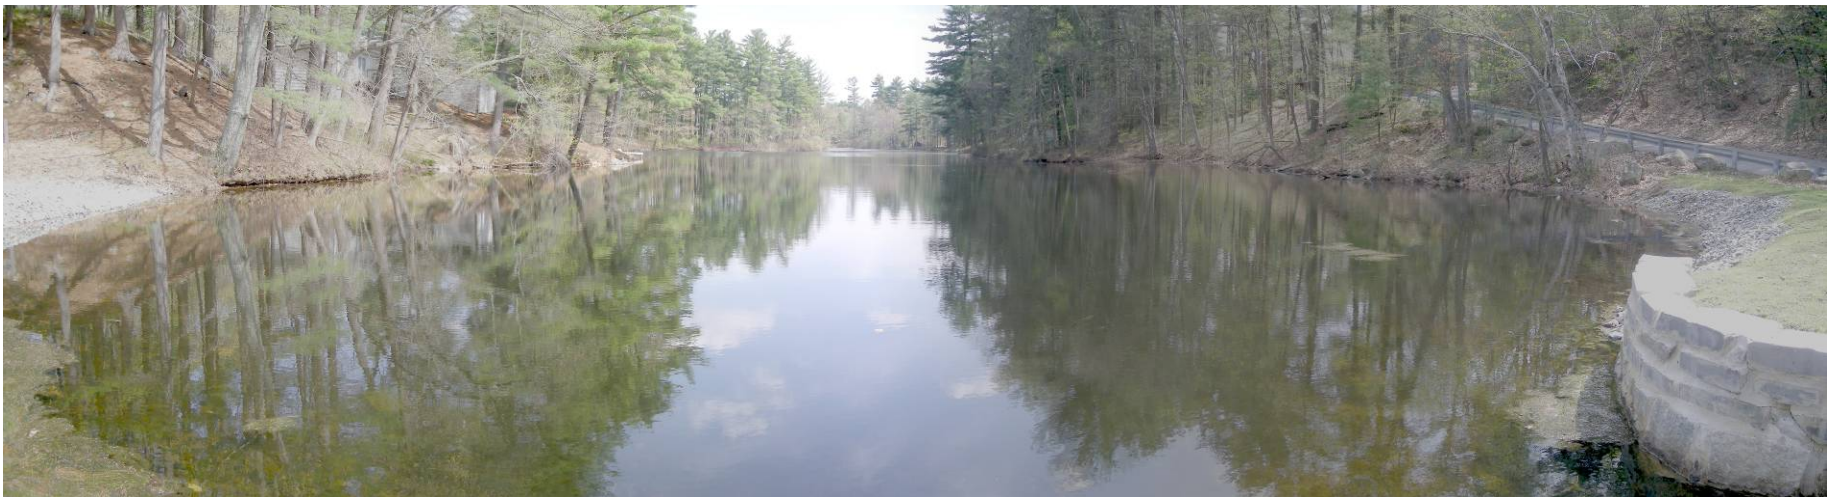
Photo 16 – Panoramic composite – Foster's Pond from the dam spillway\*
