FOSTERS POND DAM
PHASE I
INSPECTION / EVALUATION REPORT

Dam Name: Fosters Pond Dam
State Dam ID#: 5-5-9-10
NID ID#: MA00153
Owner: Foster's Pond Corporation
Owner Type: Private
Town: Andover, Massachusetts
Consultant: GEI Consultants, Inc.
Date of Inspection: November 10, 2006

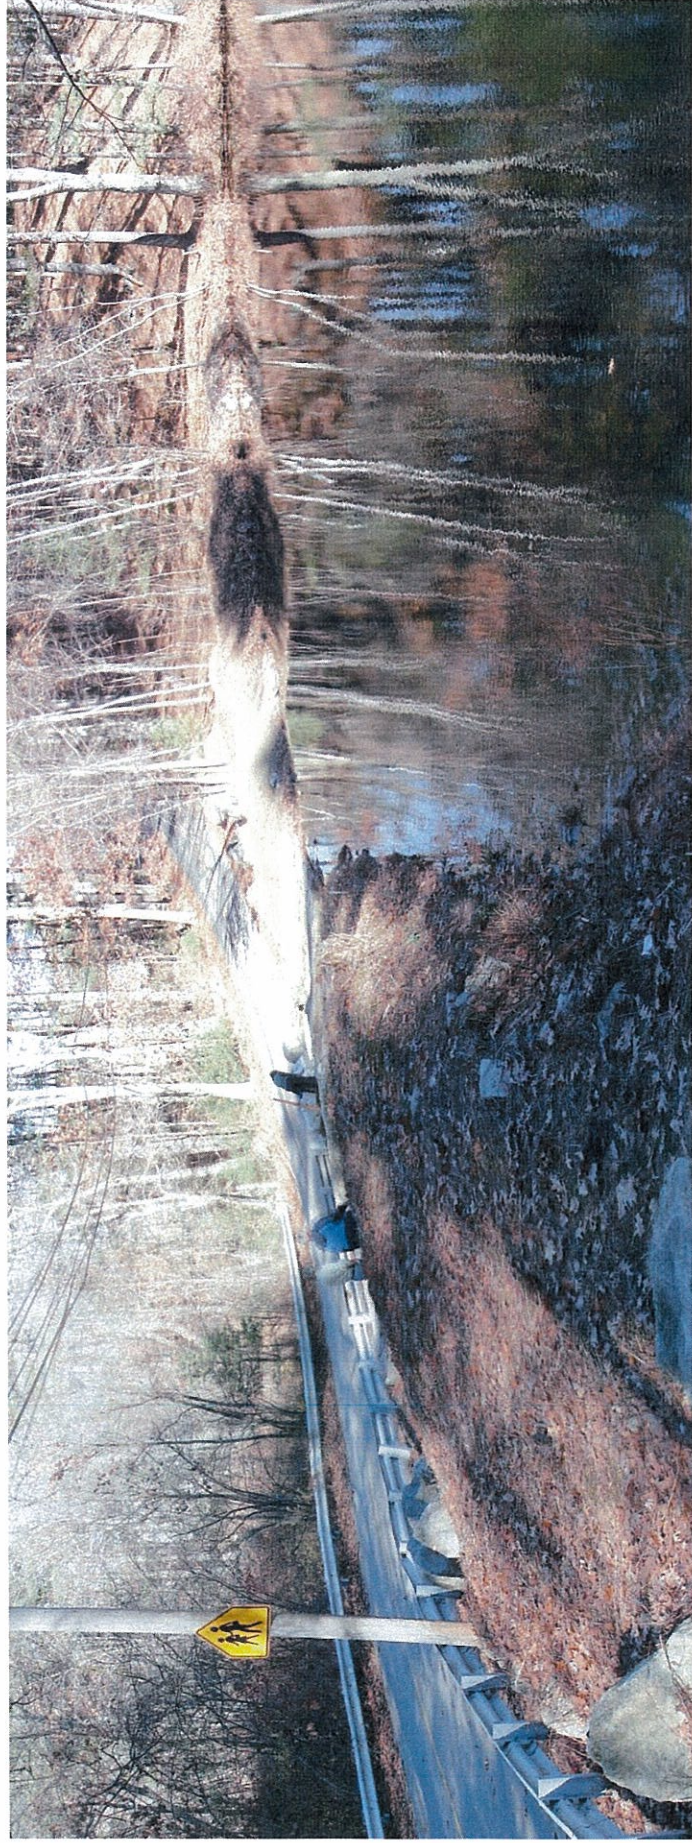
The crest of the embankment is mostly grass-covered and approximately 8 feet wide at its narrowest point. The crest elevation is very uneven along its entire length (Photos 1 and 2). The crest to the left of the sluiceway (primary outlet) is lower than the crest to the right of the main spillway and reportedly is the first area outside the primary spillway to get overtopped during high storm events. The eroded area caused by foot or canoe traffic described on the upstream face extends to the crest (Photo 3). The erosion gully caused by the dam overtopping noted on the upstream face also traverses the width of the crest (Photo 14). A sinkhole was observed

Photo 1 – Panoramic composite - Upstream slope and crest from left*

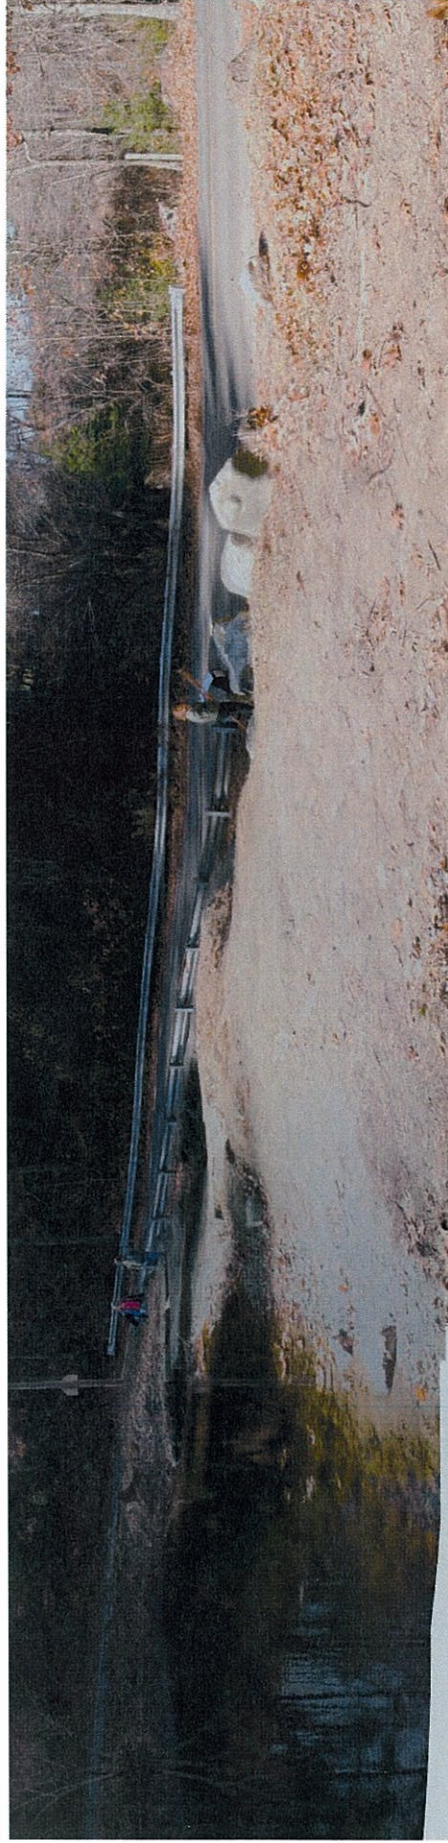
Photo 2 – Panoramic composite - Upstream slope and crest from right*

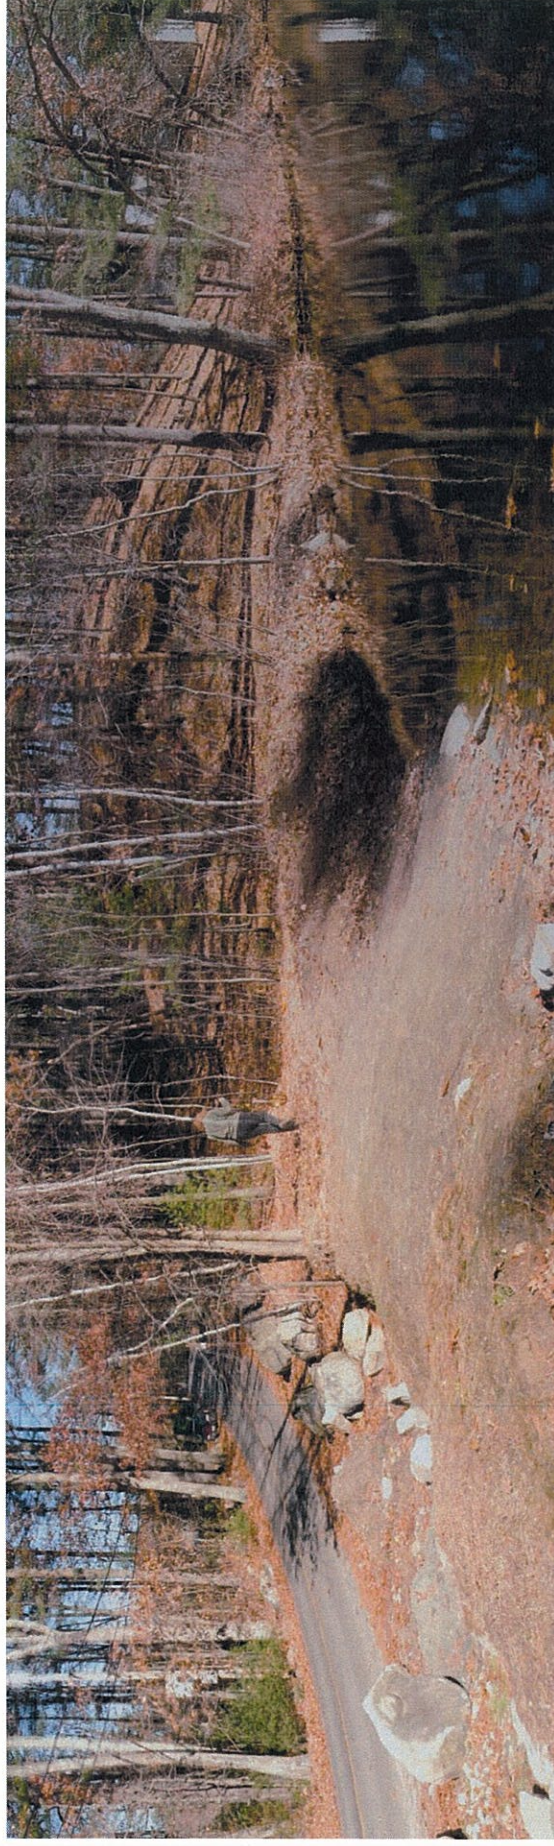
The upstream face of the embankment was mostly underwater. Visible portions showed intermittent riprap slope protection: however, riprap was missing in places, probably by wave action, erosion from previous overtopping events and/or pedestrians (Photo 18). Riprap was not observed on or near the slope leading to the main spillway. An erosion gully caused by dam overtopping in May 2006 was noted to the right side of the main spillway (Photo 14). A sinkhole was also noted at the upstream edge of the erosion gully. An area of erosion caused by foot and canoe traffic at water's edge was noted further to the right of the main spillway (Photo 3).

Photo 3 – Panoramic composite – Right abutment and crest*

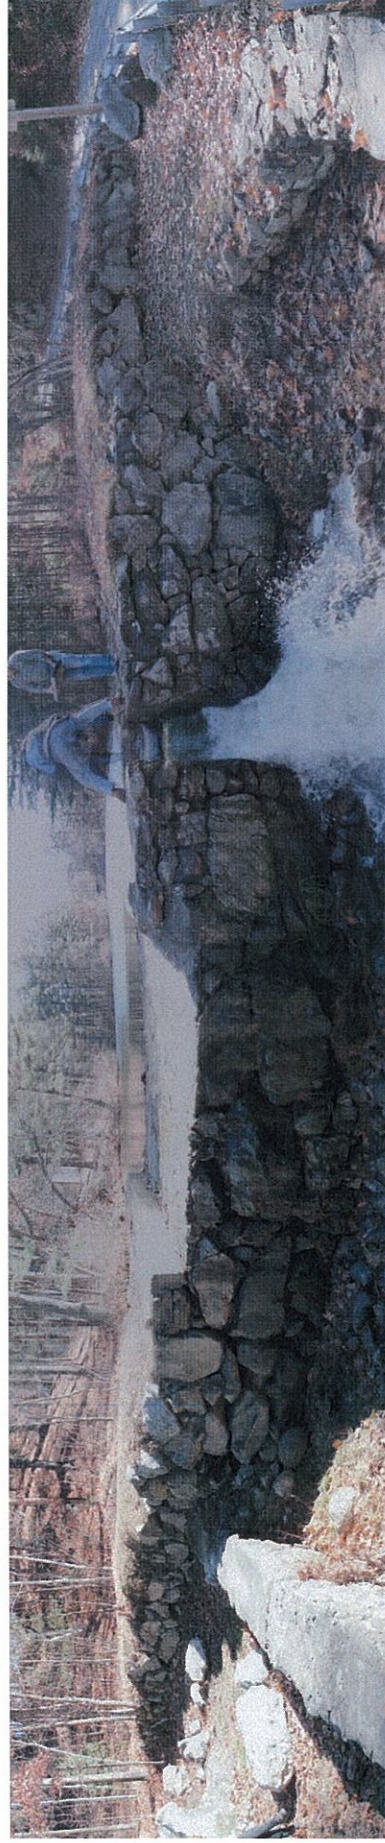
The downstream face of the dam consists of a masonry stone wall. During the inspection we noted several misaligned or missing stones along the face of the wall (Photos 5, 7, 9, 11 and 19). Two seepage areas were noted at the groin of the stone masonry wall and the dam toe within the plunge pool area; one to the left side of the sluiceway (Photo 15) and a second one to the right of the main spillway (Photo 16). Water was also observed to be flowing out of the stone masonry wall approximately 4 feet below the spillway apron near the right edge of the main spillway. The eroded area due to foot and/or canoe traffic noted in the upstream and crest areas extends to the downstream face, just above the right end of the downstream training wall (Photo 5).

Photo 5 – Panoramic composite – Downstream face, spillway, and sluiceway from downstream*

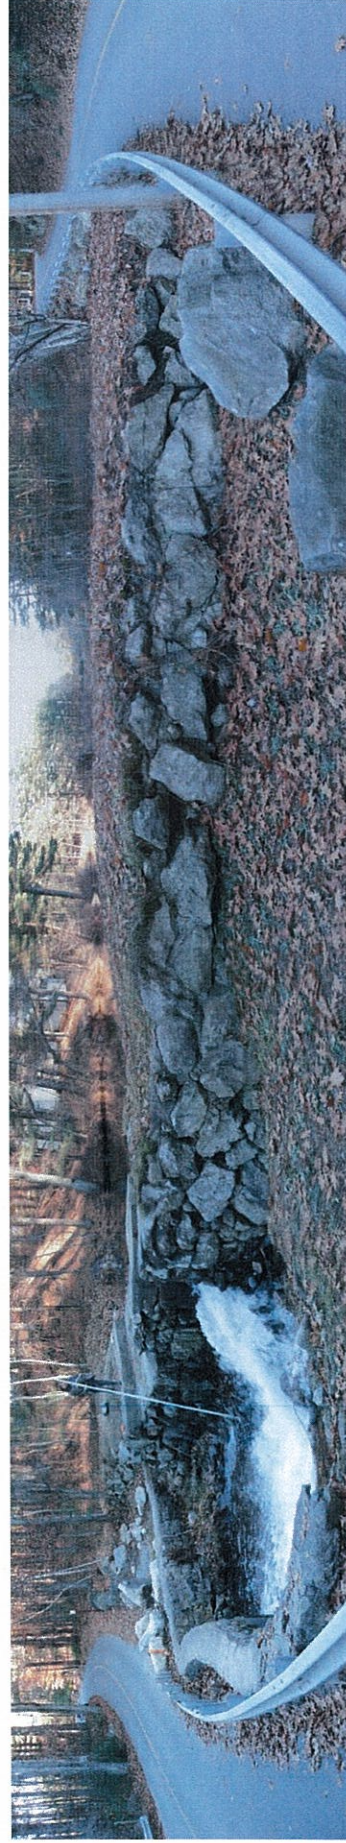
Photo 7 – Panoramic composite – Left downstream face from downstream*

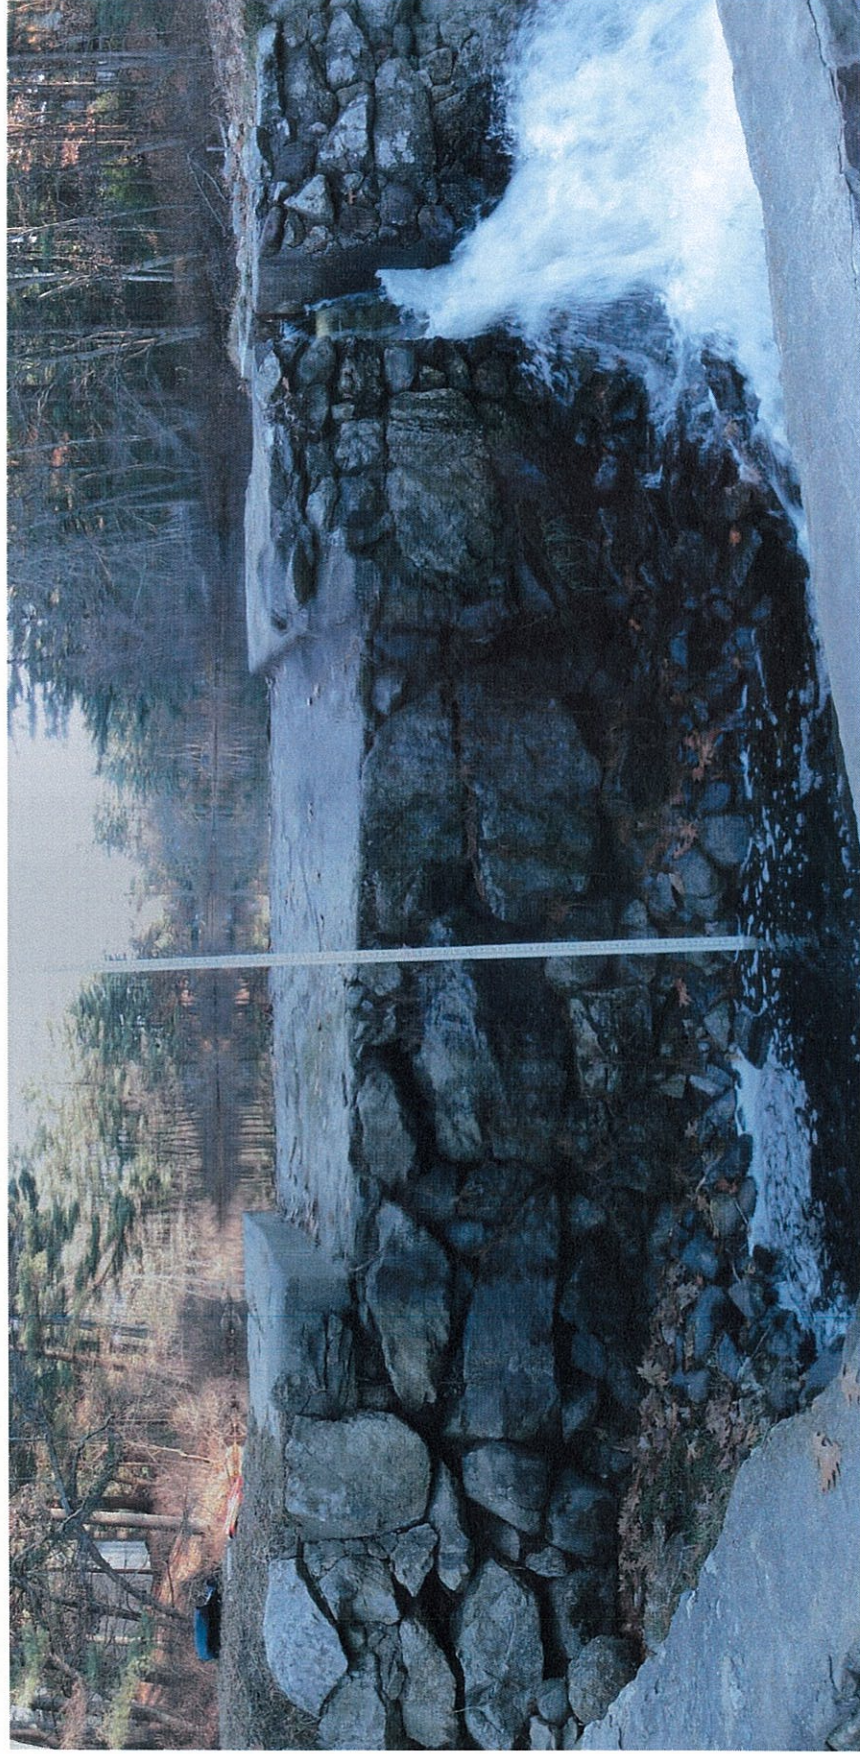
Photo 9 – Panoramic composite –Spillway, sluiceway, and plunge pool from downstream*

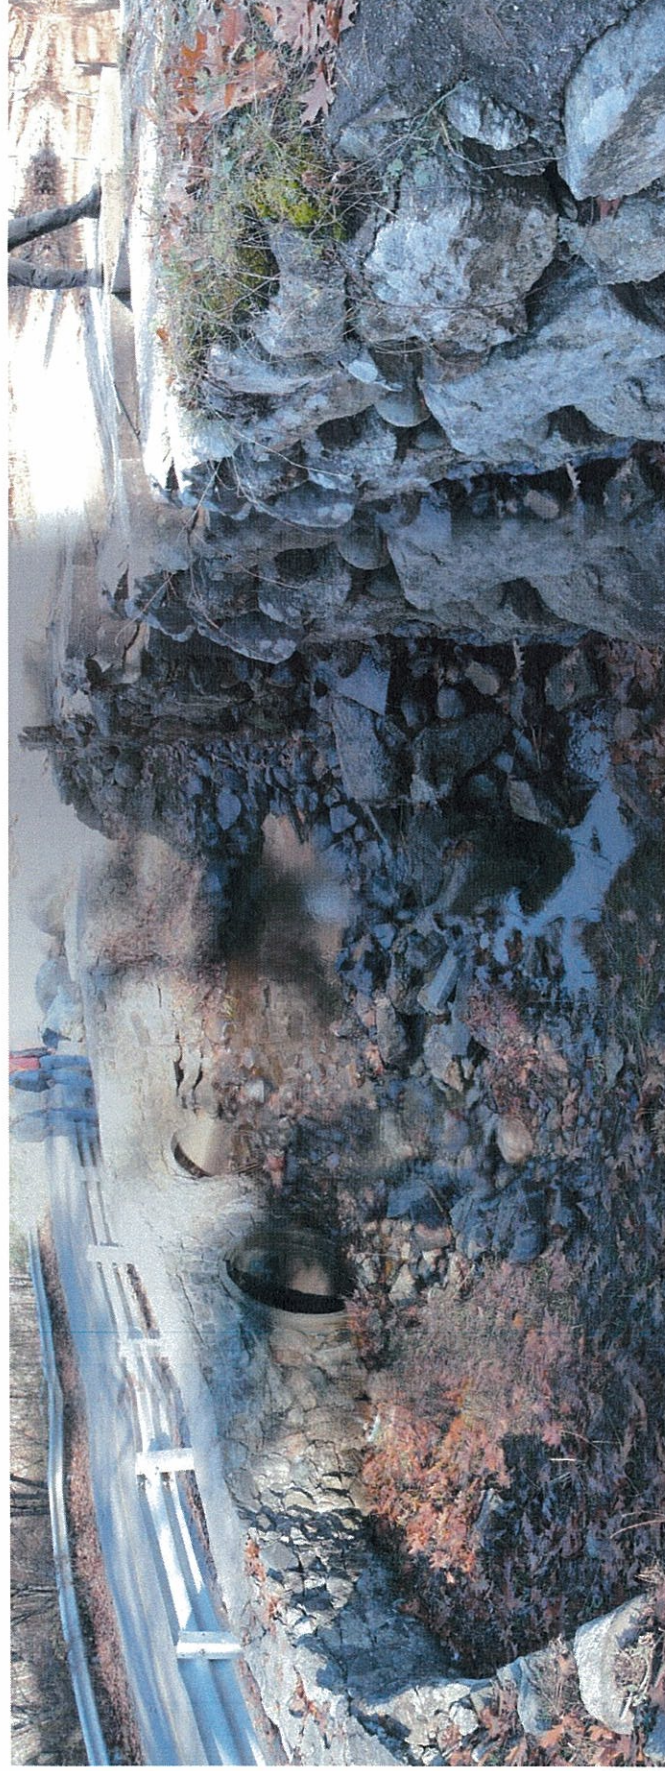
The primary spillway is in generally fair to poor condition. Minor cracking and spalling was noted on the spillway concrete apron. Longitudinal and transverse cracking was observed along the left training wall that also forms the right side of the sluiceway. A depression in the concrete on the top downstream side of this training wall was also visible (Photo 12). The left downstream side of the spillway apron appears to have settled relative to its right side (Photos 8 and 9). Some missing and misaligned stones below the concrete apron were also noted at this location (Photo 19). The left side of the mortared training wall enclosing the plunge pool has collapsed (Photos 5, 7, and 8). The plunge pool is heavily eroded with many boulders and concrete slabs fallen in possibly from previous overtopping events (Photo 11).

Photo 11 – Panoramic composite – Plunge pool from left*

1. Repair plunge pool scour by first clearing the area from accumulated rubble and placing a geotextile fabric at the base. The geotextile fabric should then be covered by a layer of gravel, smaller riprap cobbles and larger riprap. Repair mortared training wall on downstream left side of plunge pool.

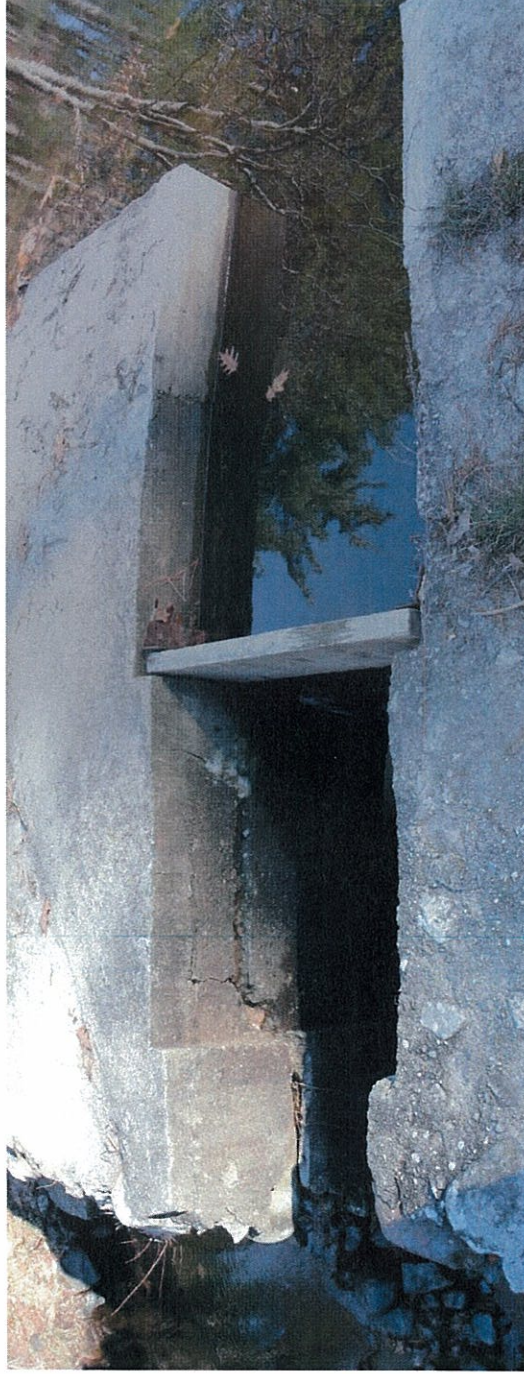
The sluiceway is in satisfactory condition with recent concrete repairs visible on the concrete structure. However, several longitudinal and transverse cracks are still noted on both the right and left side of the sluiceway (Photos 12 and 13). The unmortared training wall along the left approach to the sluiceway appears to be in fair condition. A trash rack was not observed

Photo 12 – Panoramic composite – Sluiceway outlet*

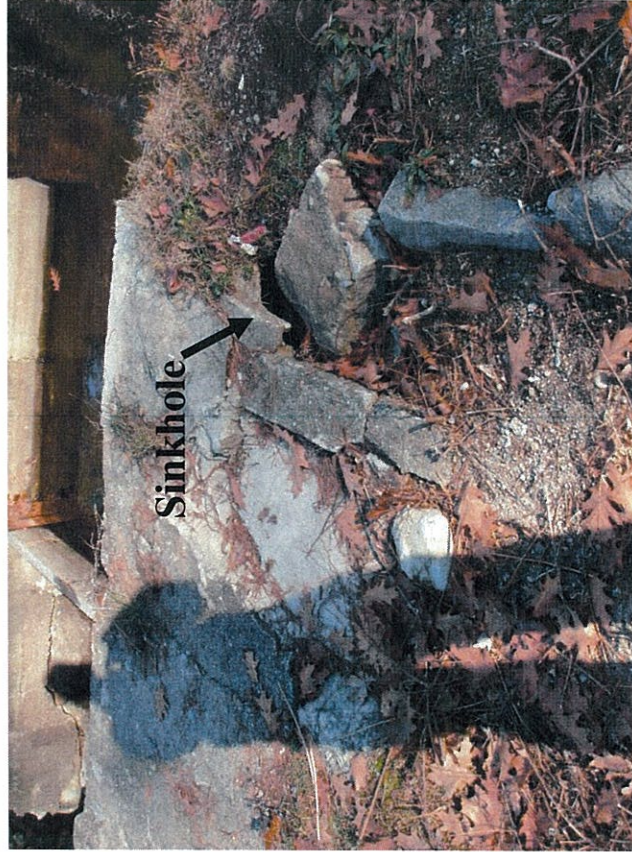
Photo 13 – Sinkhole on left side of sluiceway

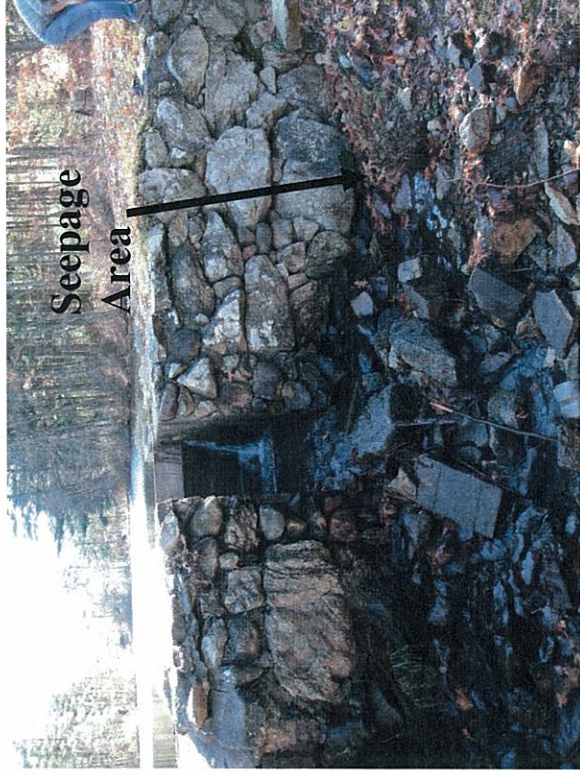
Photo 15 Sluiceway and seepage area on left side

NAME OF DAM: <u>Fosters Pond Dam</u>		STATE ID #: <u>5-5-9-10</u>	
INSPECTION DATE: <u>November 10, 2006</u>		NID ID #: <u>MA00153</u>	
EMBANKMENT			
AREA INSPECTED	CONDITION	OBSERVATIONS	NO ACTION MONITOR REPAIR
D/S SLOPE	WET AREAS (NO FLOW) SEEPAGE SLIDE, SLOUGH, SCARP EMB.-ABUTMENT CONTACT SINKHOLE/ANIMAL BURROWS EROSION UNUSUAL MOVEMENT VEGETATION (PRESENCE/CONDITION)	Stone masonry wall on downstream side. See "Masonry Walls" page for additional descriptions	
		None observed	X
		Three locations: See Note 1	X
		Some misaligned stones, some missing stones	
		Good	
		Missing masonry stones	X
		At edge of crest to right of spillway, above mortared training wall (see Note 2)	
		None observed	X
		Grass-covered downstream of stone wall outside stilling basin (see note 3).	
ADDITIONAL COMMENTS: 1. (a) At base of masonry wall to left of spillway (b) Through masonry wall, ~4 feet below spillway apron, near right edge of spillway (c) At base of masonry wall, ~4 feet to the left of sluiceway (Photos 15 and 16)

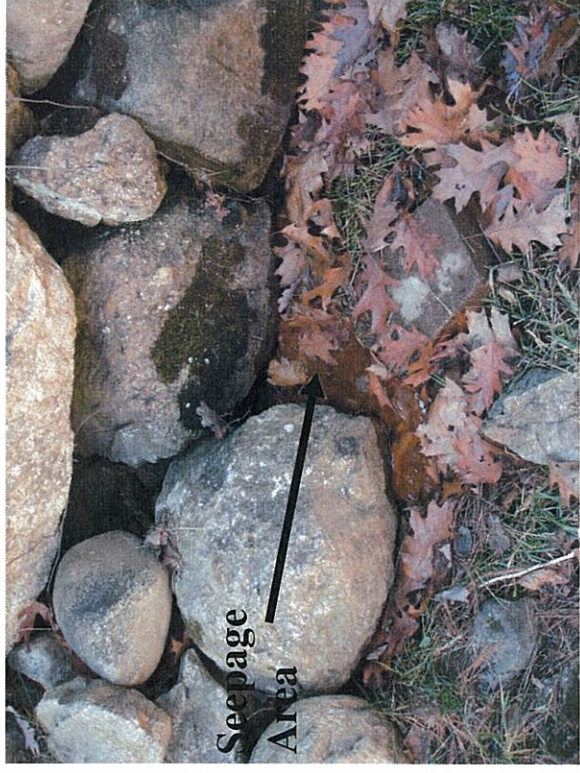
Photo 16 – Seepage on right side, at toe

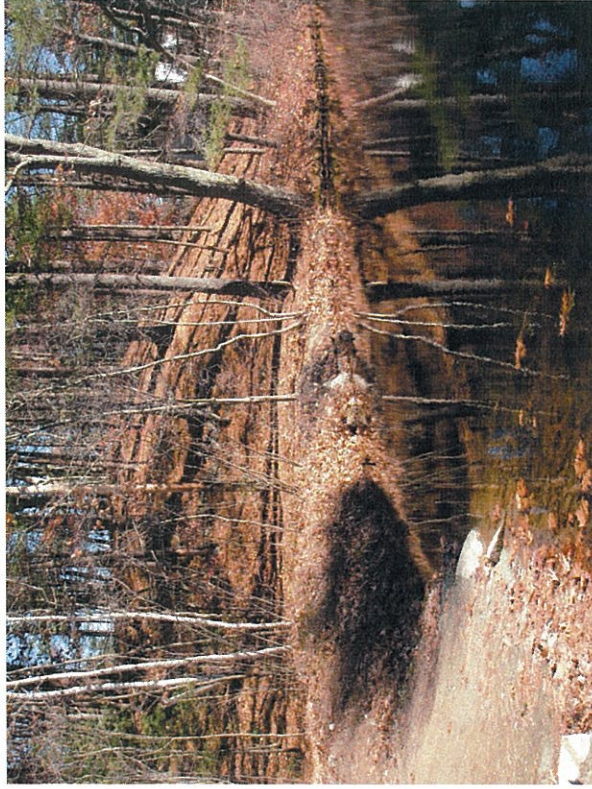
Photo 18 – Missing riprap on upstream slope

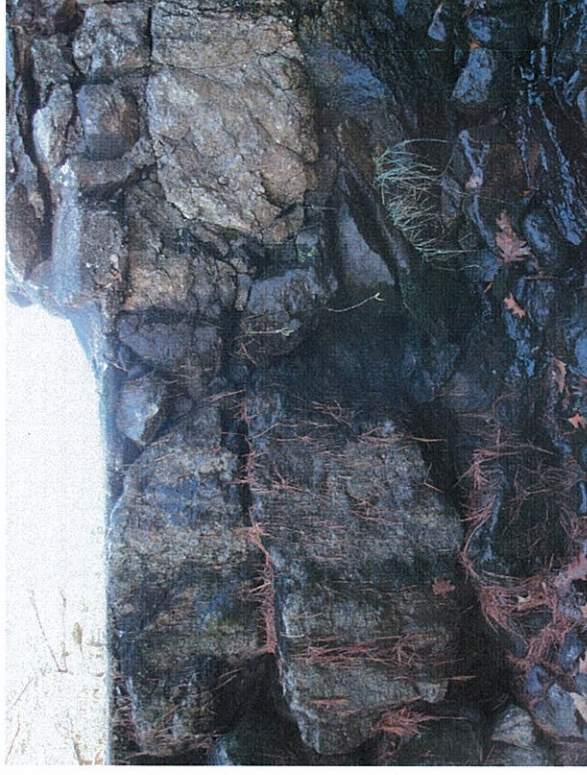
Photo 19 – Missing stones from downstream masonry wall
