-- FOSTER'S POND DAM --
PHASE I
INSPECTION / EVALUATION REPORT

Dam Name: Foster's Pond Dam
State Dam ID#: 5-5-9-10
NID ID#: MA00153
Owner: Foster's Pond Corporation
Town: Andover, Massachusetts
Consultant: GEI Consultants, Inc.
Date of Inspection: November 18, 2011

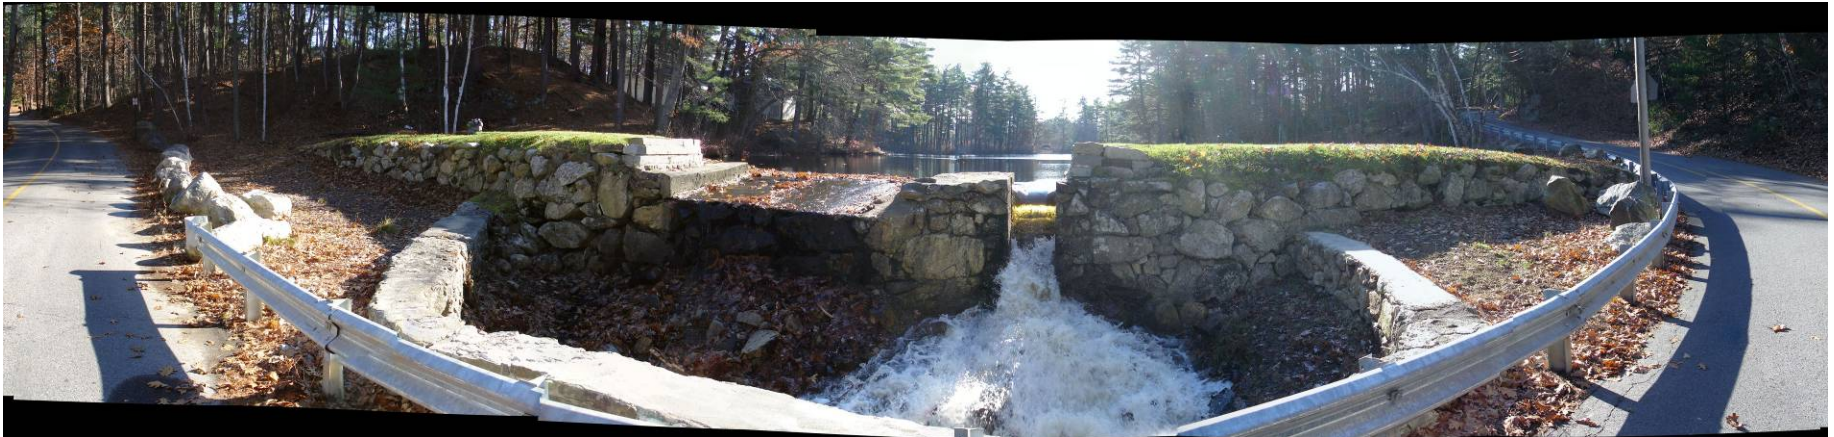
Photo 3 – Panoramic composite – Downstream side of dam at spillway*

- Several sink-holes had formed on the crest of the left / southwest embankment of the dam immediately adjacent to the mortared masonry wingwall (see Photos 3 & 4). The deepest sinkhole was at least 3.5 feet deep. The sinkholes extended through the upper embankment soil which appeared to consist of sandy silt / silty sand.
- The mortared masonry blocks of the upstream part of the left spillway wingwall had moved out (away from the embankment) and had gaps of up to about ¾ inch at joints between the masonry blocks. The movement may be the result of frost action pushing on the wingwall.
- At least two holes appeared in the concrete crest of the spillway which opened into voids that extended 1 to 2 feet into the crest structure. The voids appeared to be formed in a cobble, gravel and soil matrix.

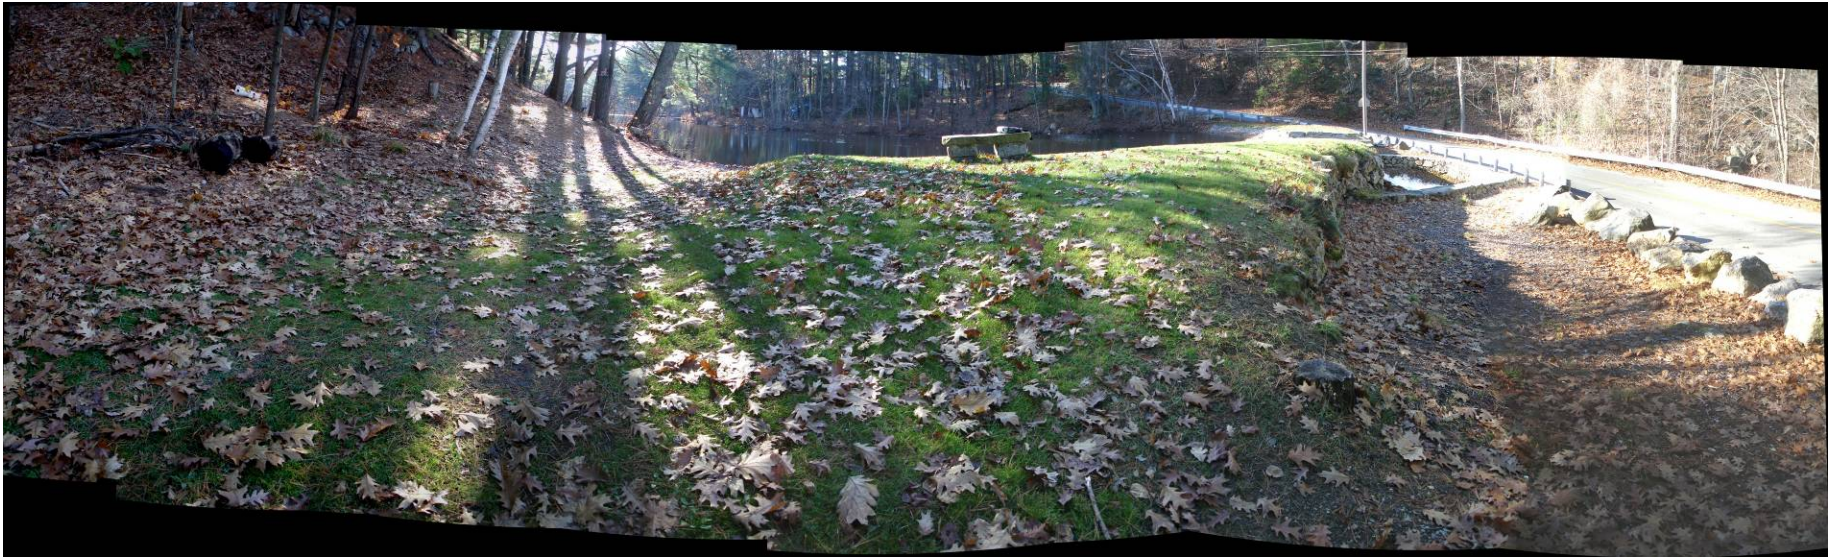
Photo 6 – Panoramic composite – Right embankment and auxiliary spillway*

The lower part of the upstream face of the embankment was underwater and not observed. The visible, upper portions of the upstream face were covered with small cobble / crushed stone to within about a ½ foot of the crest. Generally, grassed topsoil covers the top of the upstream face. The geotextile that underlies the riprap and cover soils was exposed on the upper part of the right embankment near the emergency spillway.

The swale along the right abutment of the dam serves as an emergency spillway and is in good condition. The emergency spillway channel is lined with a geotextile which is covered with cobbles upstream, grass cover across the spillway crest, and mulch cover downstream of the spillway.

Cover the exposed geotextile on the right embankment with seeded topsoil to protect it from degradation.

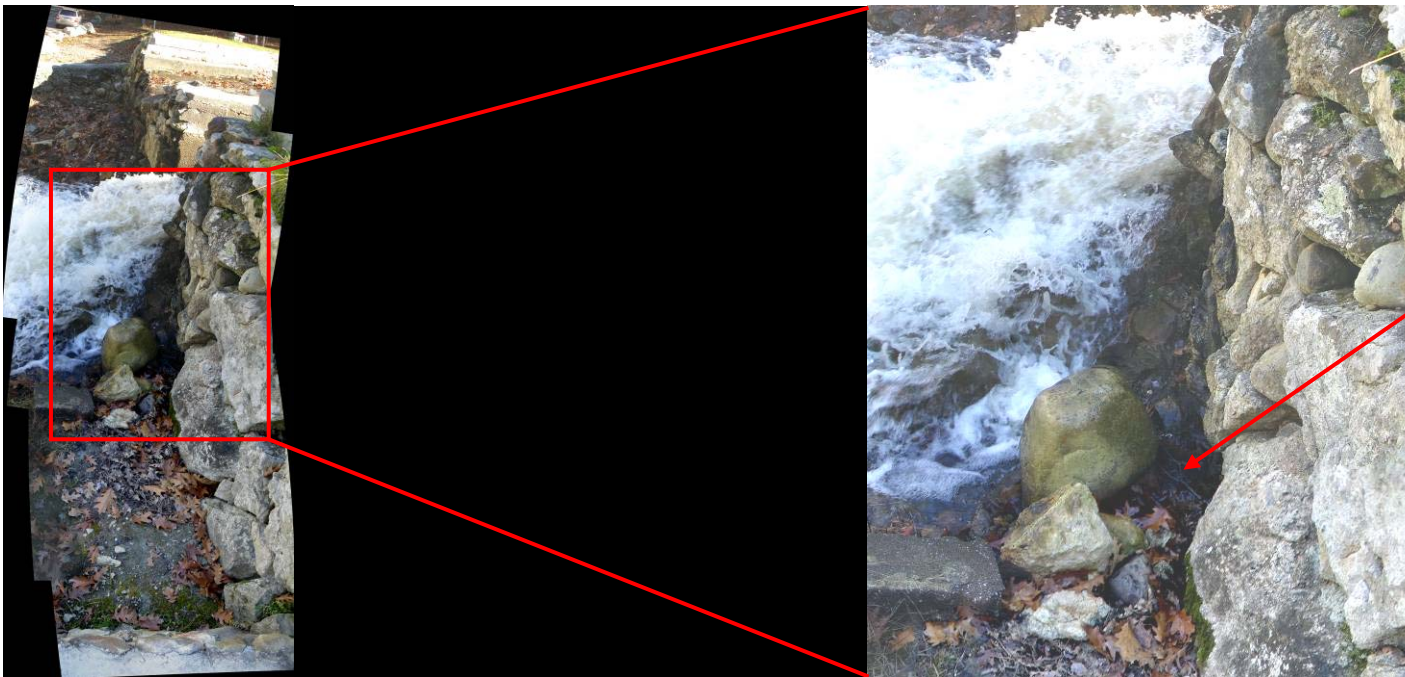
Photo 15 – Panoramic composite – seepage area near sluiceway*

The downstream face of the dam consists of a masonry stone wall with an irregular profile. The masonry is largely unmortared except for below the spillway. One seepage area was noted at the dam toe within the plunge pool area, a few feet southwest of the sluiceway (see Photo 15).

Water flow from wall at
toe of left embankment
in plunge pool before fix

With the recent measures to block flow from the end of the sluiceway into the stone masonry, the observed locations of seepage have been eliminated. However, the dam does not have a filtered seepage collection system and may be vulnerable to seepage at either higher pond levels or if the embankment degrades (e.g., frost heave). We judge the current seepage stability to be satisfactory but we recommend regular monitoring for new seepage.

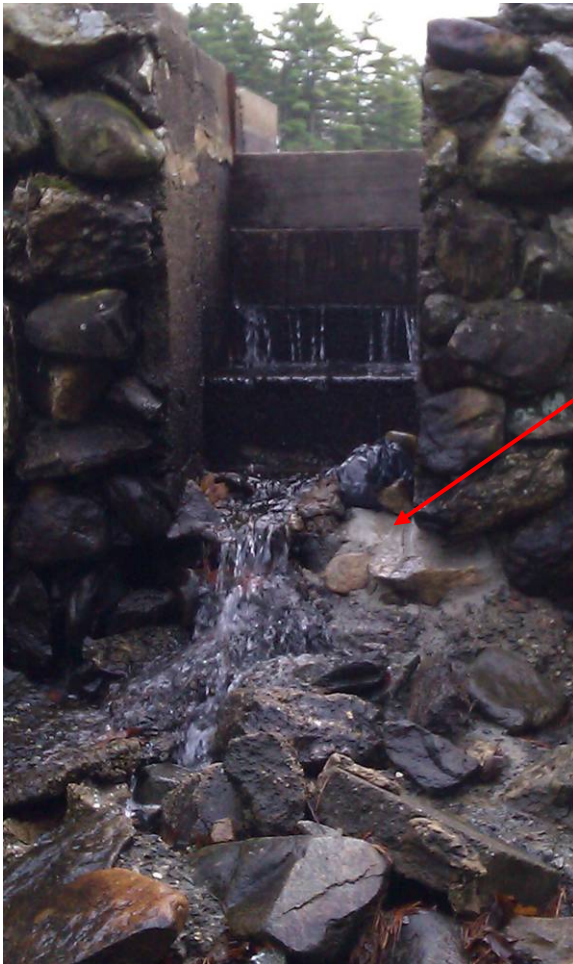
Photo 16 – Sluiceway repair**

New concrete placed in
sluiceway to cut off flow
being diverted to behind
the wall
