-- FOSTER'S POND DAM --
PHASE I
INSPECTION / EVALUATION REPORT

Dam Name: Foster's Pond Dam
NID ID#: MA00153
Owner: Foster's Pond Corporation
Town: Andover
Consultant: GEI Consultants, Inc.
Date of Inspection: December 6, 2016

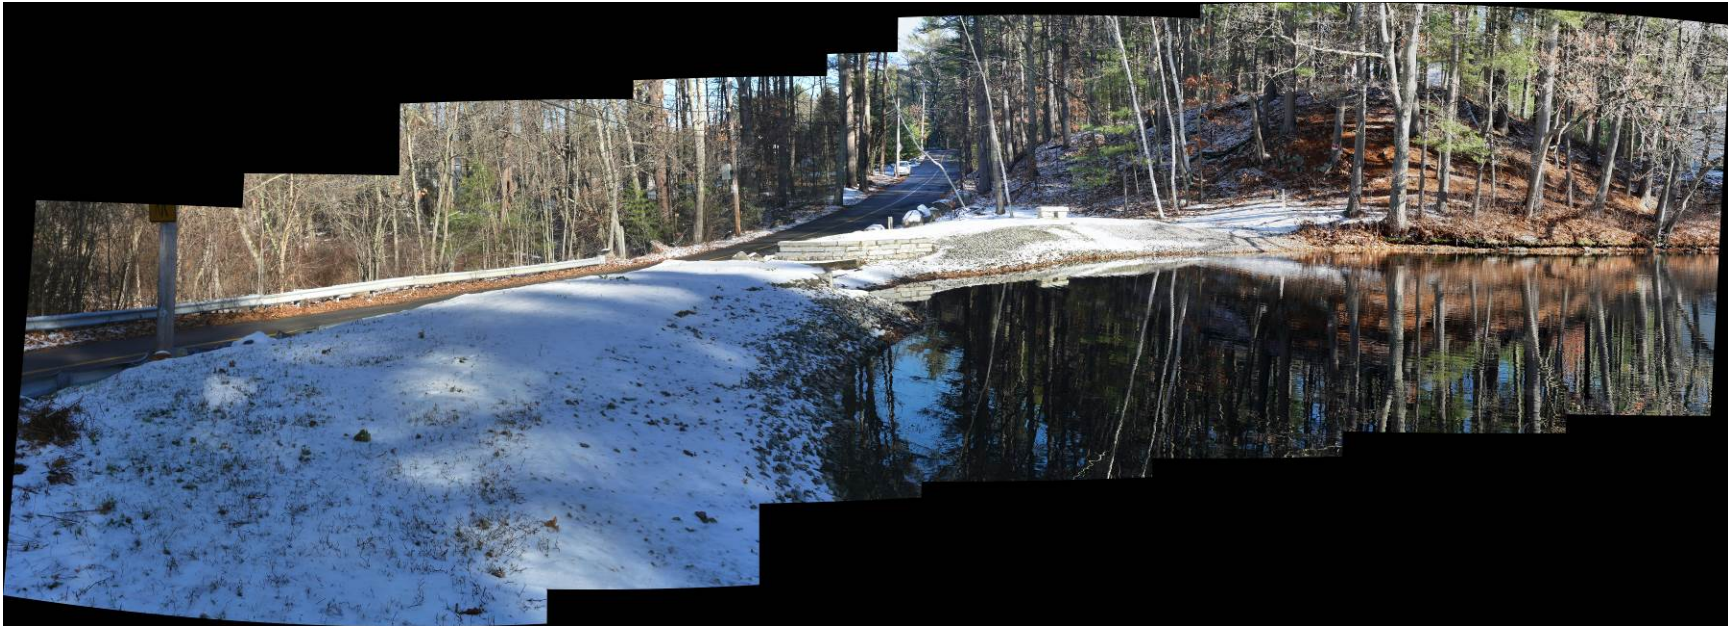
Photo 1 – Upstream slope and crest from left*

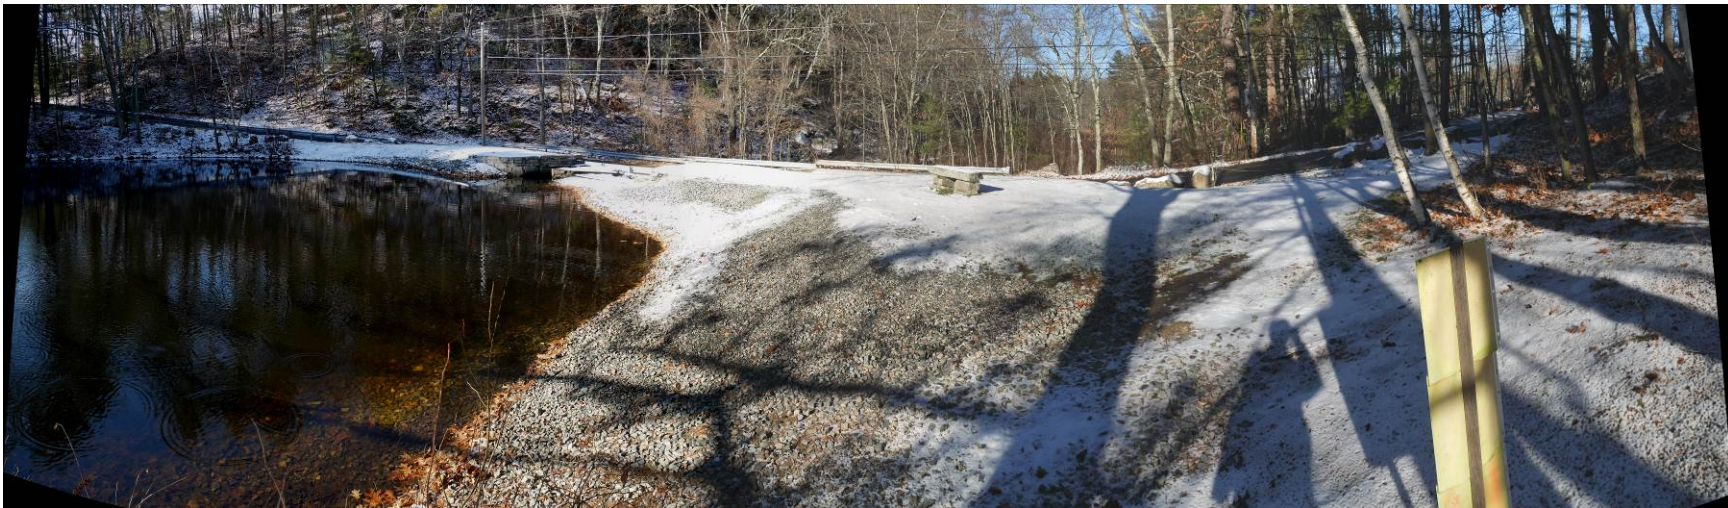
Photo 2 – Upstream slope and crest from right*

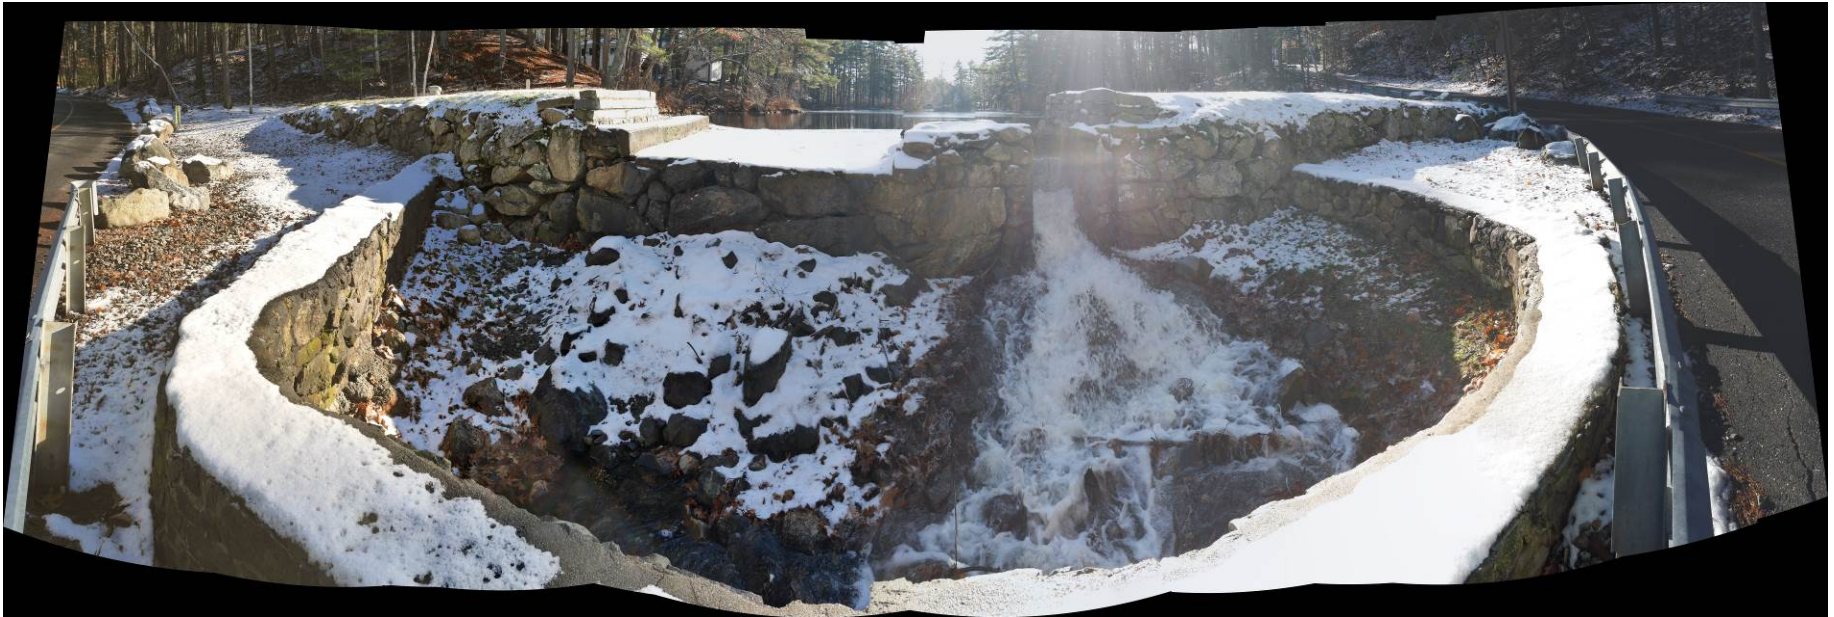
Photo 3 – Downstream side of dam at spillway*

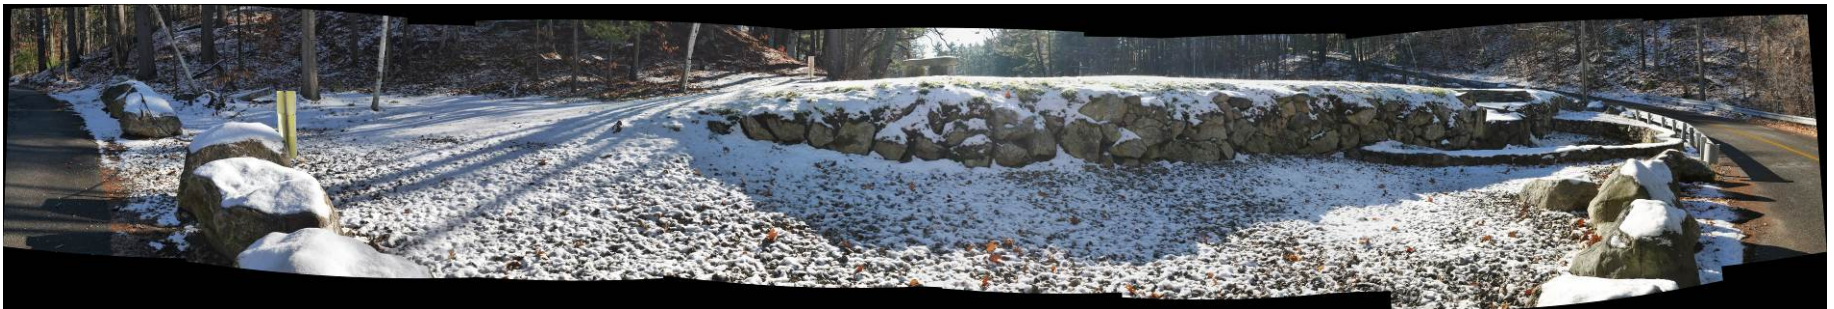
Photo 4 – Downstream side, right embankment*

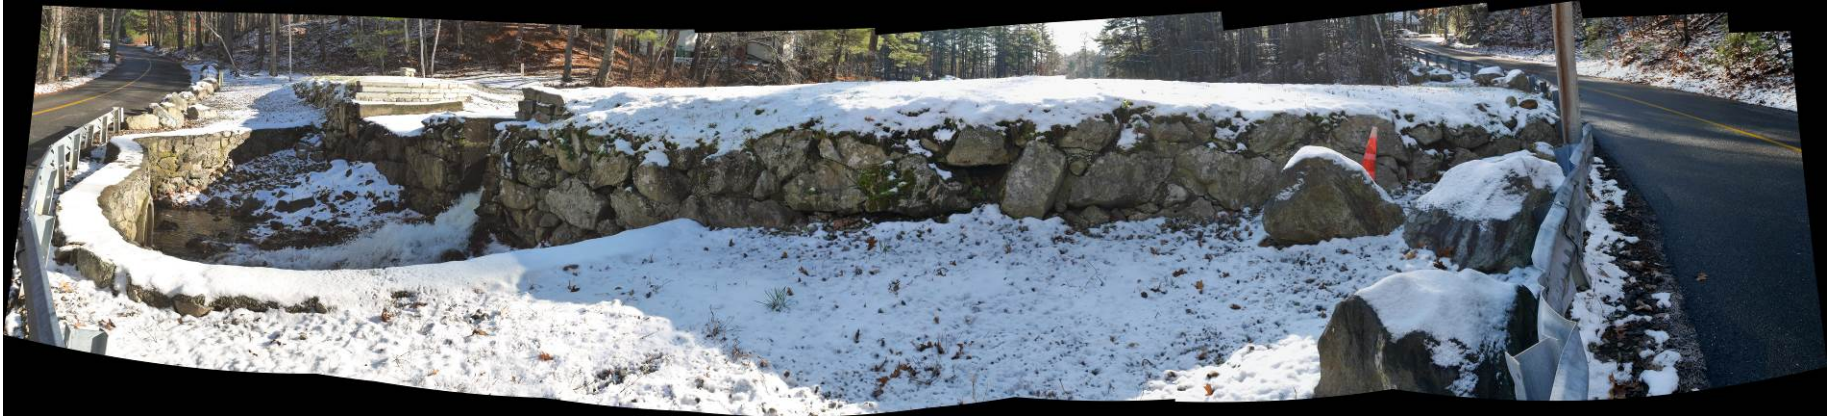
Photo 5 – Downstream side, left embankment*

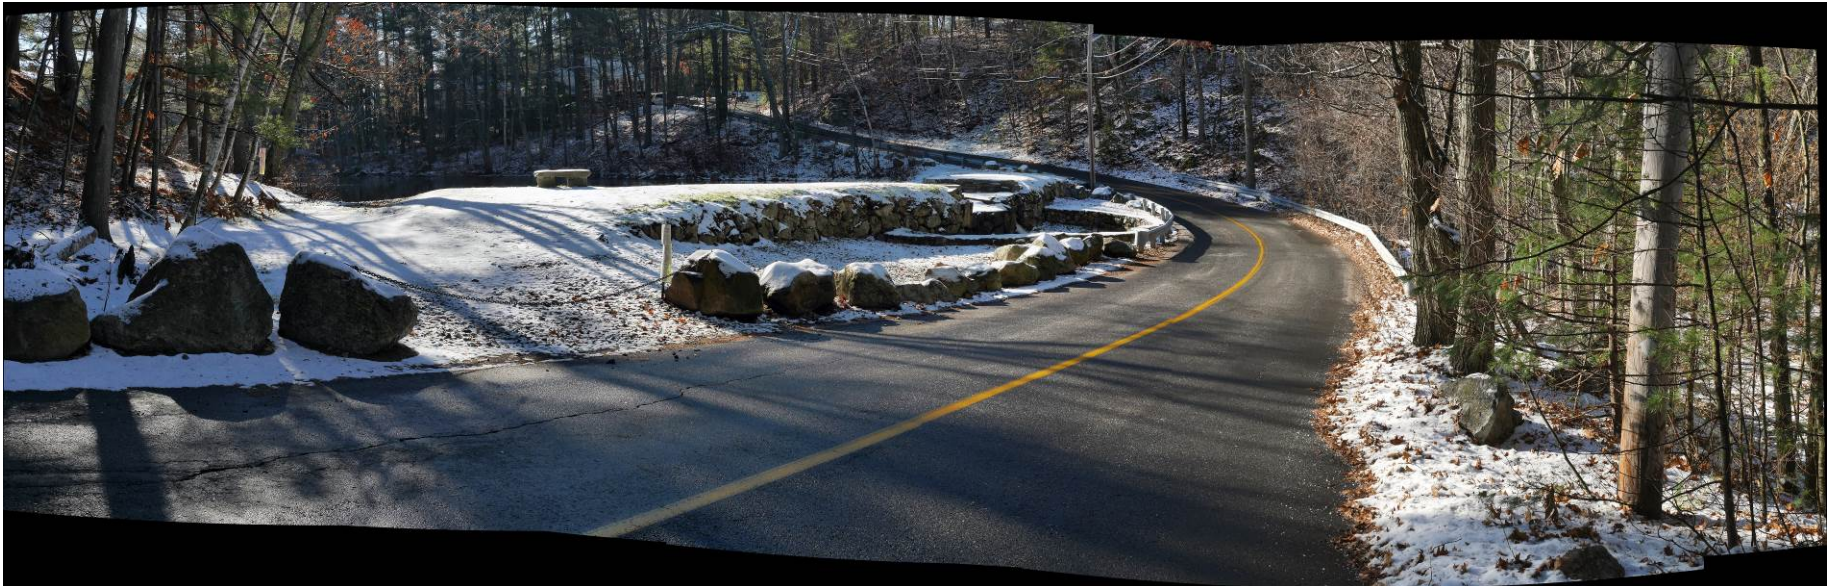
The swale along the right abutment of the dam serves as an emergency spillway and is in good condition. The emergency spillway channel is lined with a geotextile, which is covered with cobbles upstream, grass cover across the spillway crest, and mulch cover downstream of the spillway.

Photo 6 – Right embankment and auxiliary spillway*

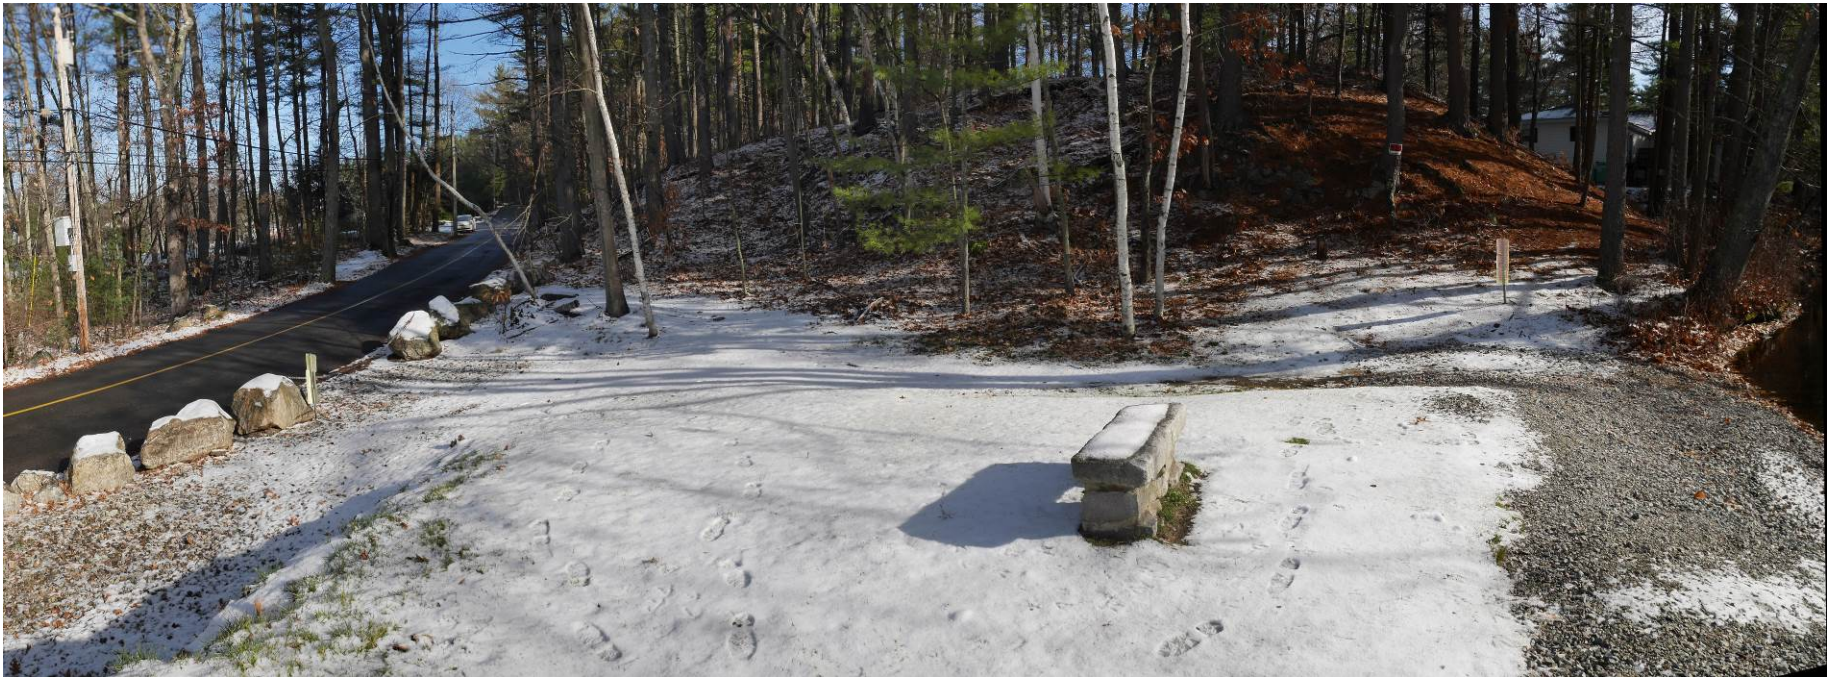
Photo 7 – Right abutment and auxiliary spillway*

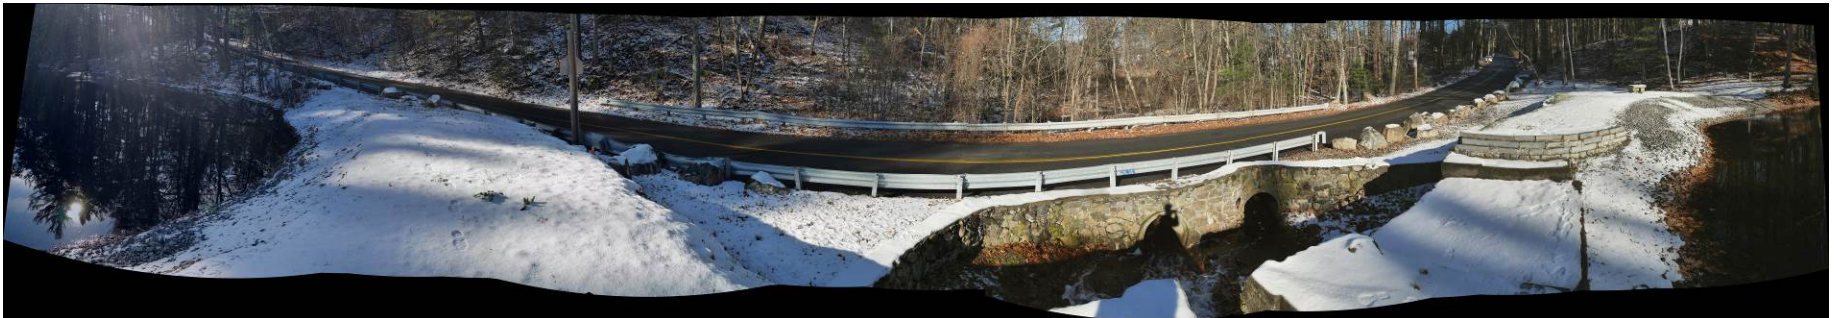
Photo 8 – View downstream from dam crest, Rattlesnake Road*

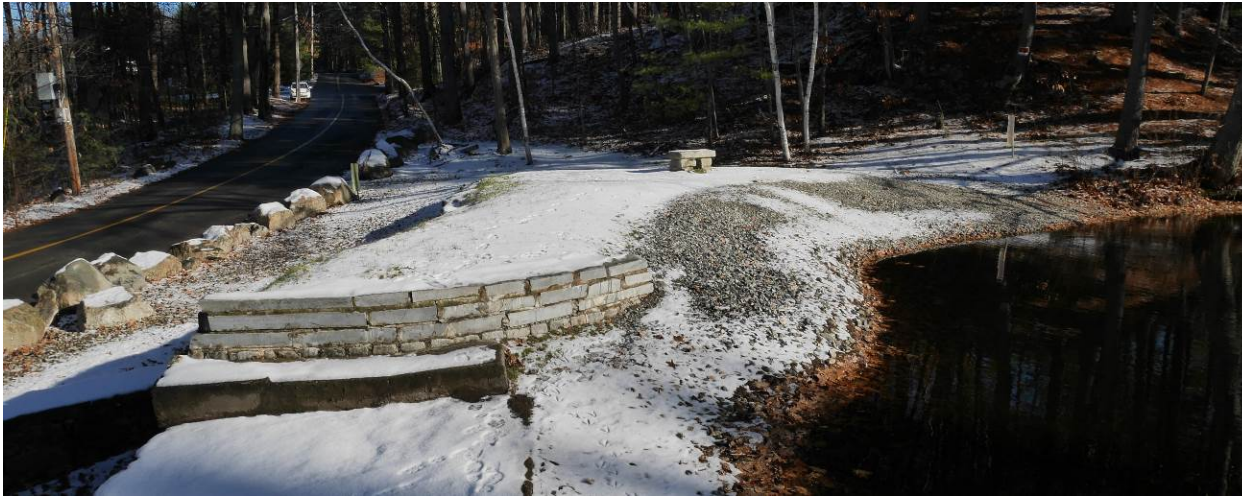
Photo 9 – Right embankment and right spillway training wall*

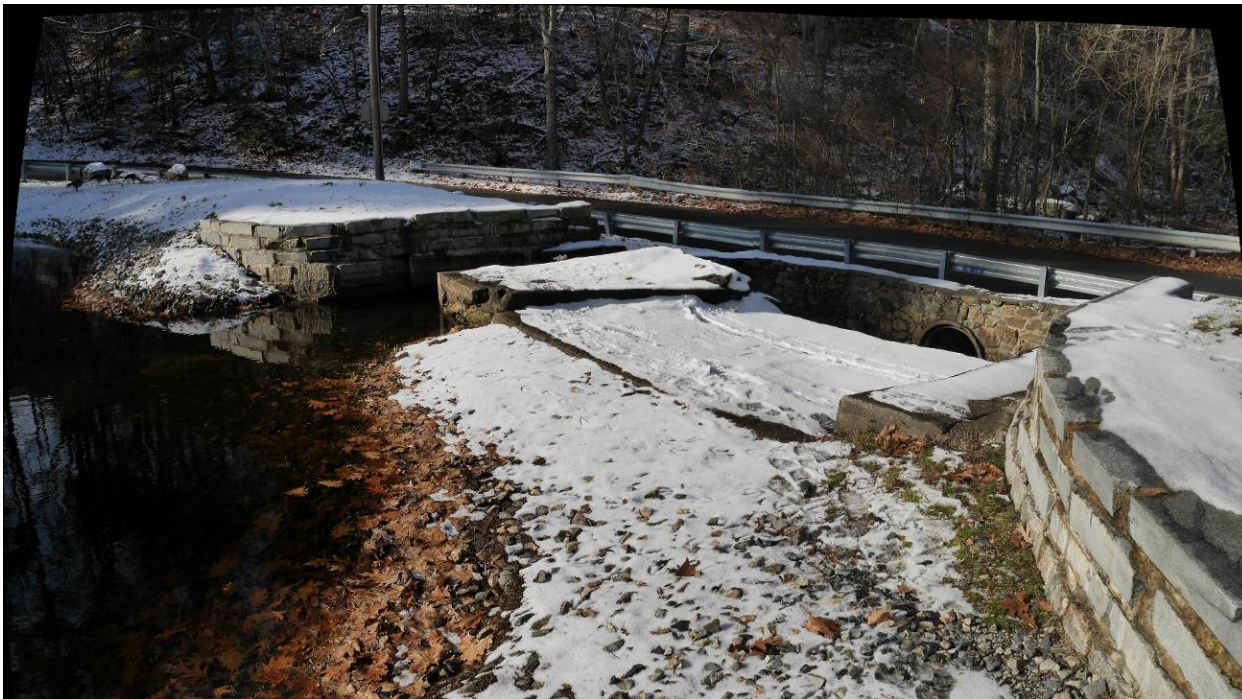
Photo 10 – Spillway and sluiceway upstream side*

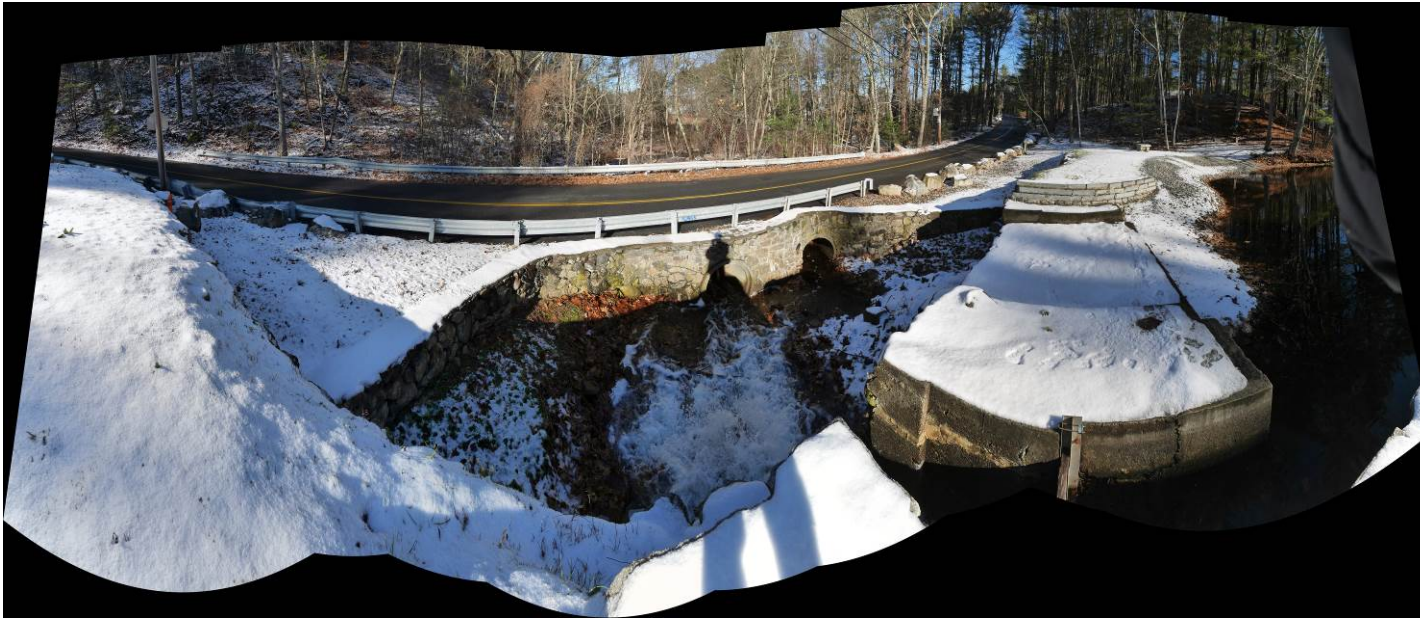
Photo 11 – Spillway plunge pool from upstream*

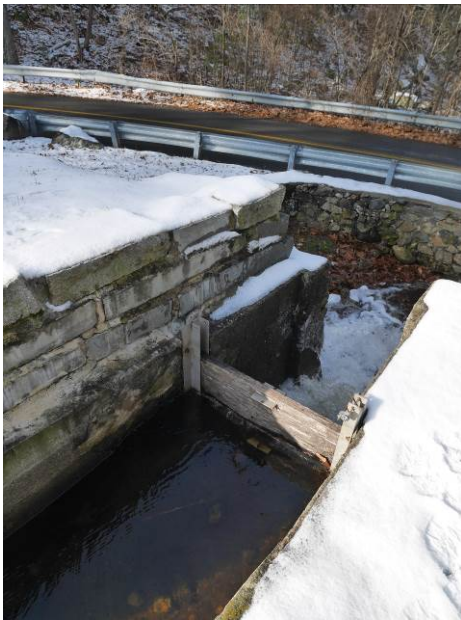
The sluiceway is in good condition. An 8-inch cast-iron pipe, described as being installed through the sluiceway and serving as the low-level outlet, has reportedly corroded and been abandoned. The pipe was reportedly filled and covered with concrete when the sluiceway was restored in 2005. Flows through the sluiceway are directed into the same plunge pool as flows from the main spillway. New stainless steel brackets / slots provide a secure means of securing the stoplogs.

Photo 12 – Sluiceway stoplogs and new metal slots

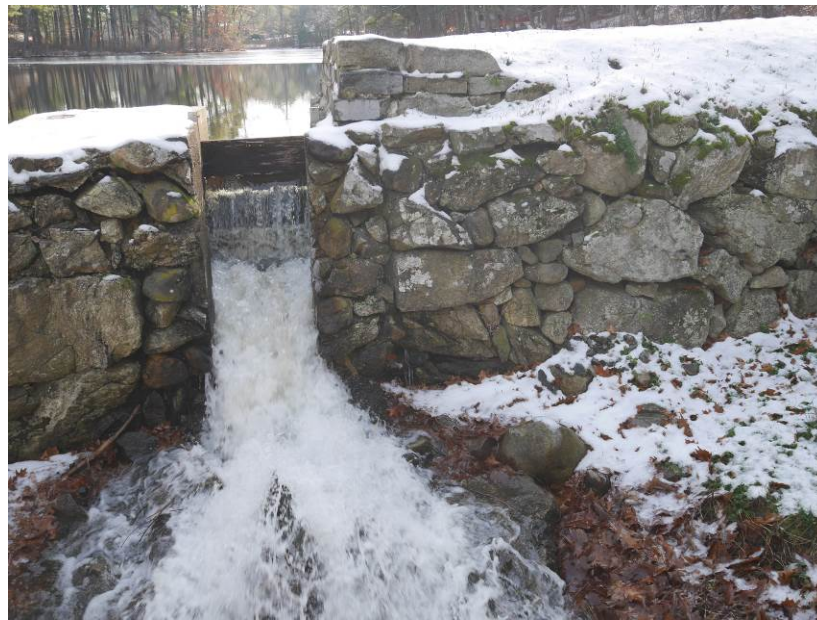
Photo 13 – Sluiceway from downstream
