--FOSTER'S PONDS DAM--
PHASE I
INSPECTION / EVALUATION REPORT

Dam Name: Foster's Pond Dam
NID ID#: MA00153
Owner: Foster's Pond Corporation
Town: Andover, MA
Consultant: GEI Consultants, Inc.
Date of Inspection: November 5, 2021

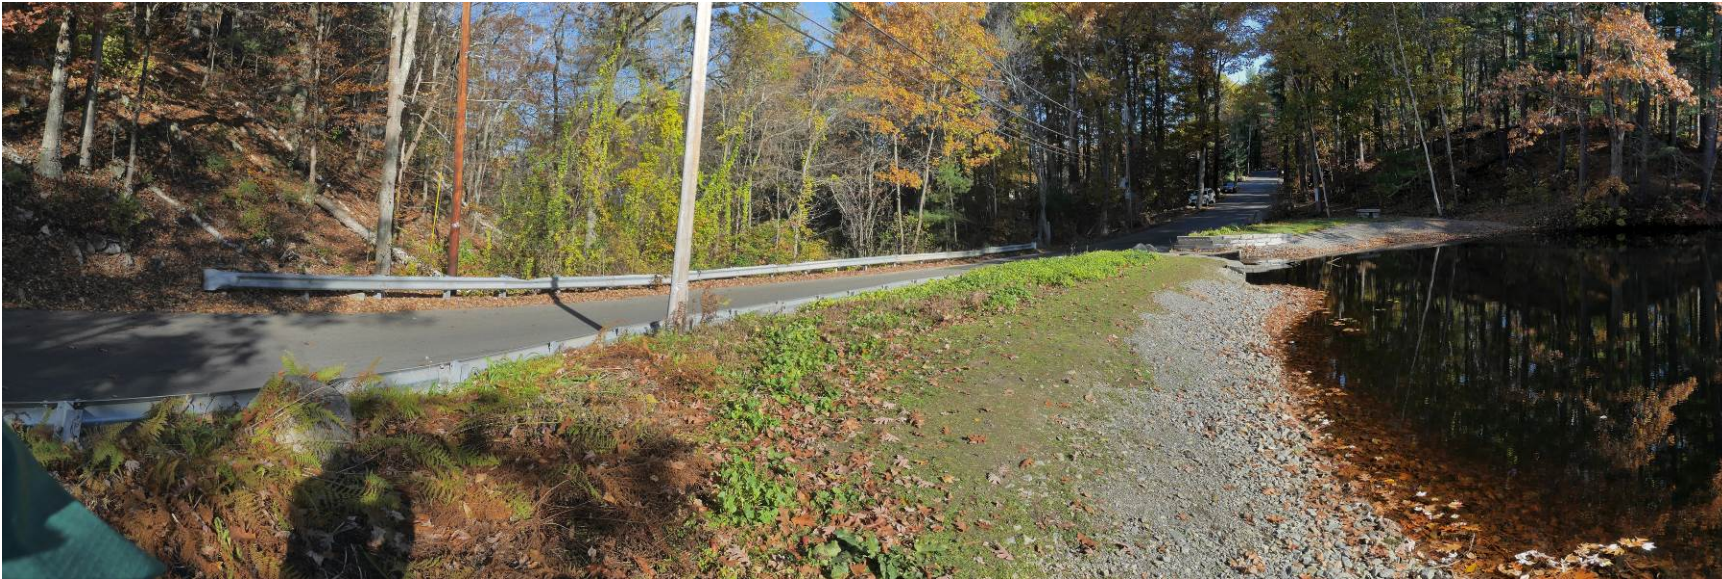
The crest of the embankment mostly had vegetation cover that included short grass, violets, and ferns. A few bare spots were noted but no erosion has taken place. The crest has a relatively consistent grade along its entire length with a slight slope upstream and downstream from its center. A small stone bench has been constructed on the right embankment.

Photo 1 – Upstream slope and crest from left*

- Continue with the maintenance and monitoring activities described in the O&M Manual and as practiced over the past few years.
- Reestablish grass cover in bare areas. Consider use of bio-degradable erosion control matting or blankets to protect seeded areas from pedestrian traffic, geese, and washout.

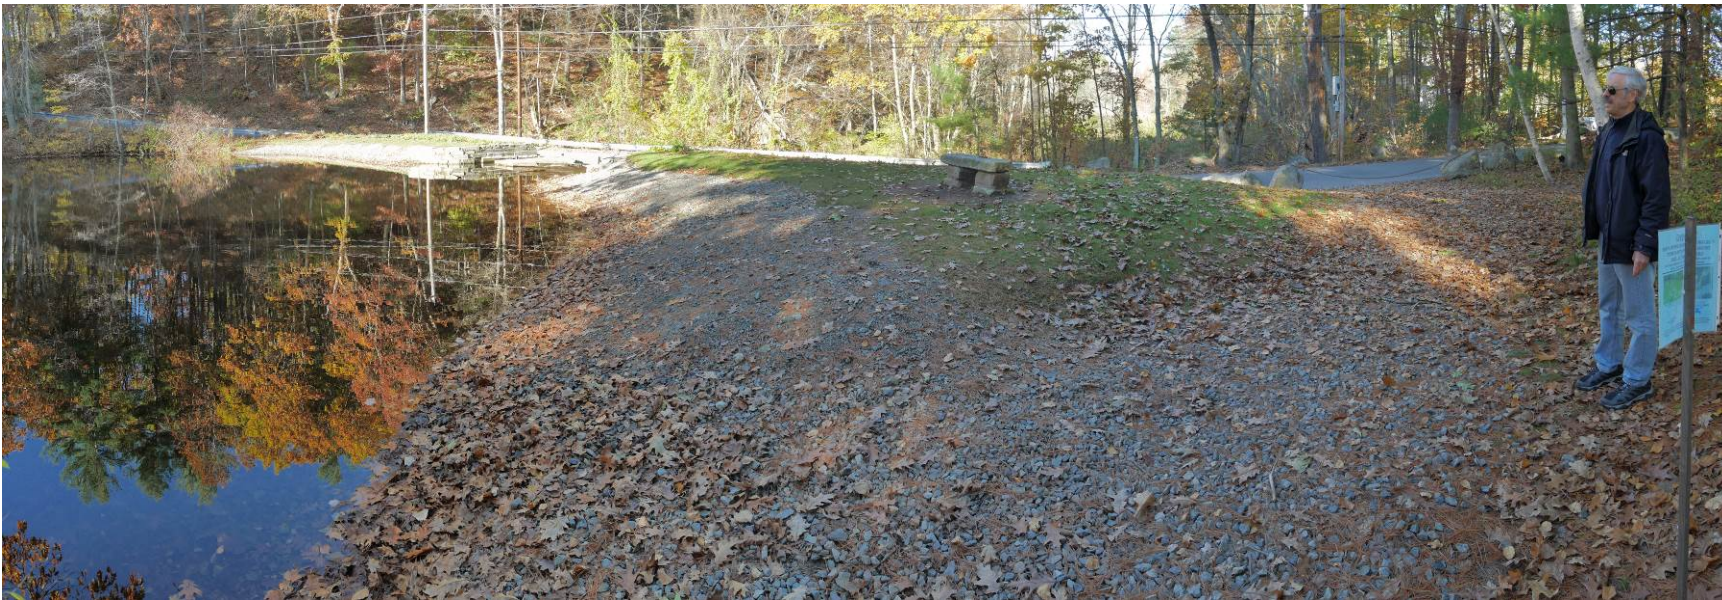
Photo 2 – Upstream slope and crest from right*

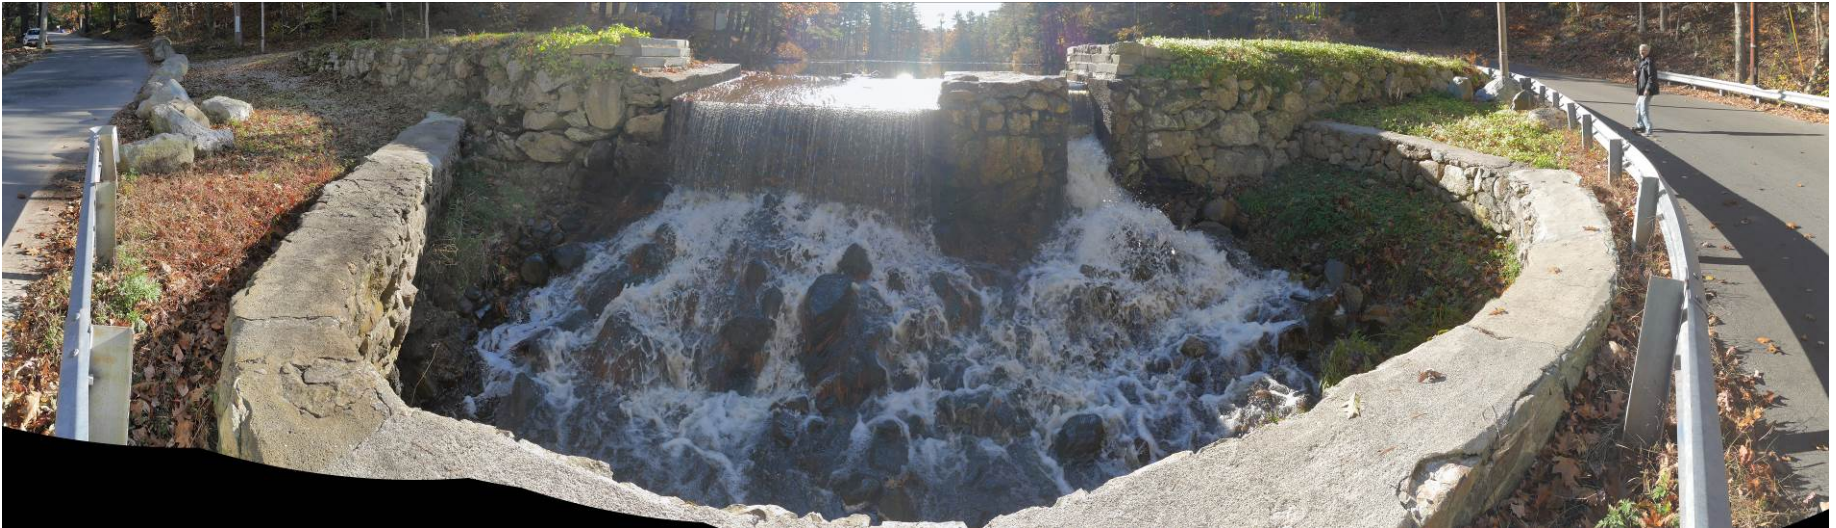
Photo 3 – Downstream side of dam at spillway*

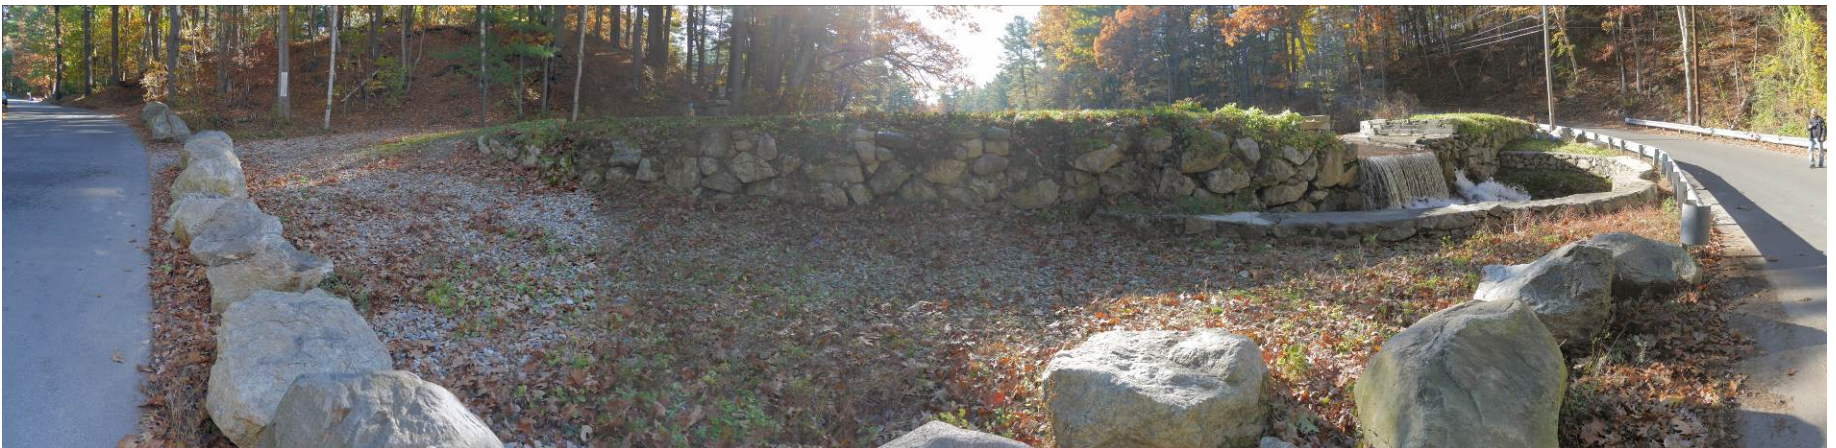
Photo 4 – Downstream side, right embankment*

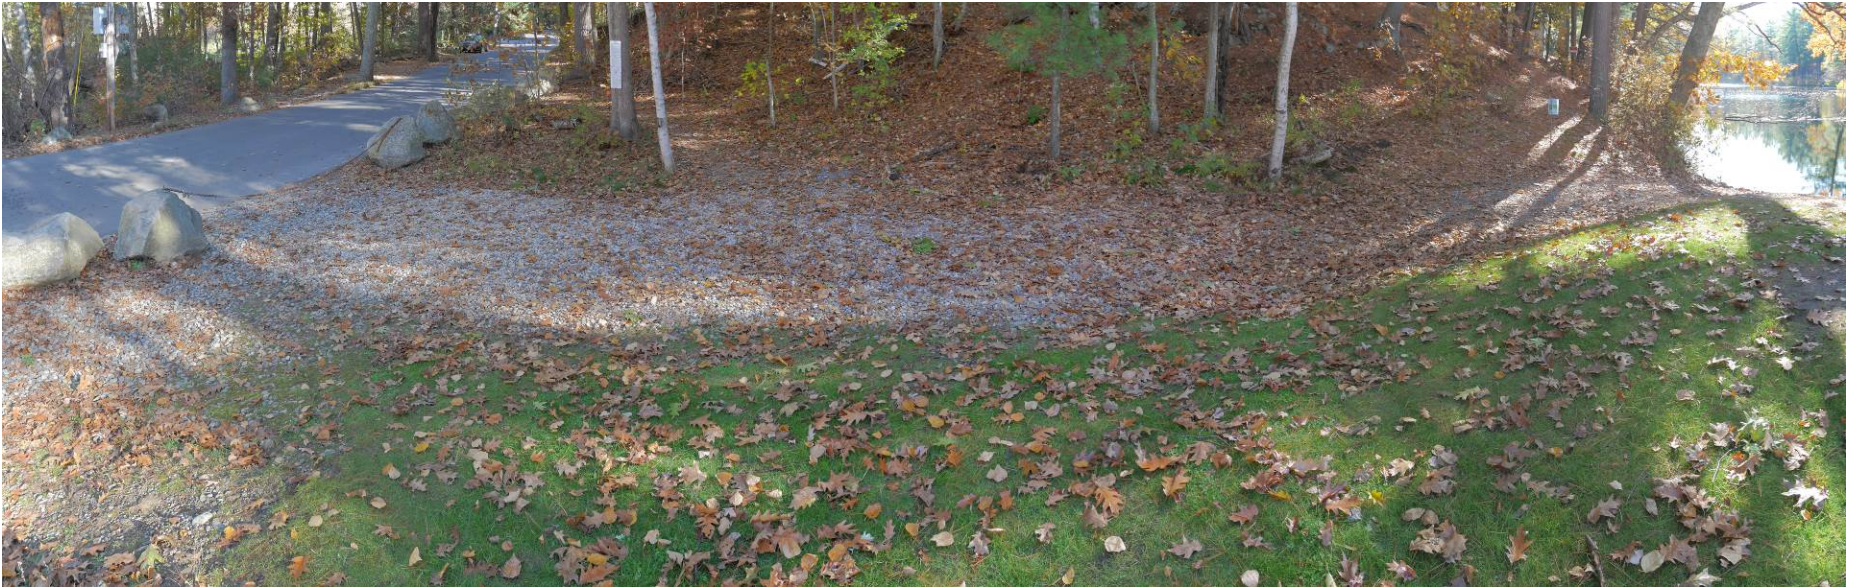
The swale along the right abutment of the dam serves as an emergency spillway and is in good condition. The emergency spillway channel is lined with a geotextile, which is covered with gravel. The gravel extends from the pond to Rattlesnake Hill Road.

Photo 5 – Right abutment and auxiliary spillway*

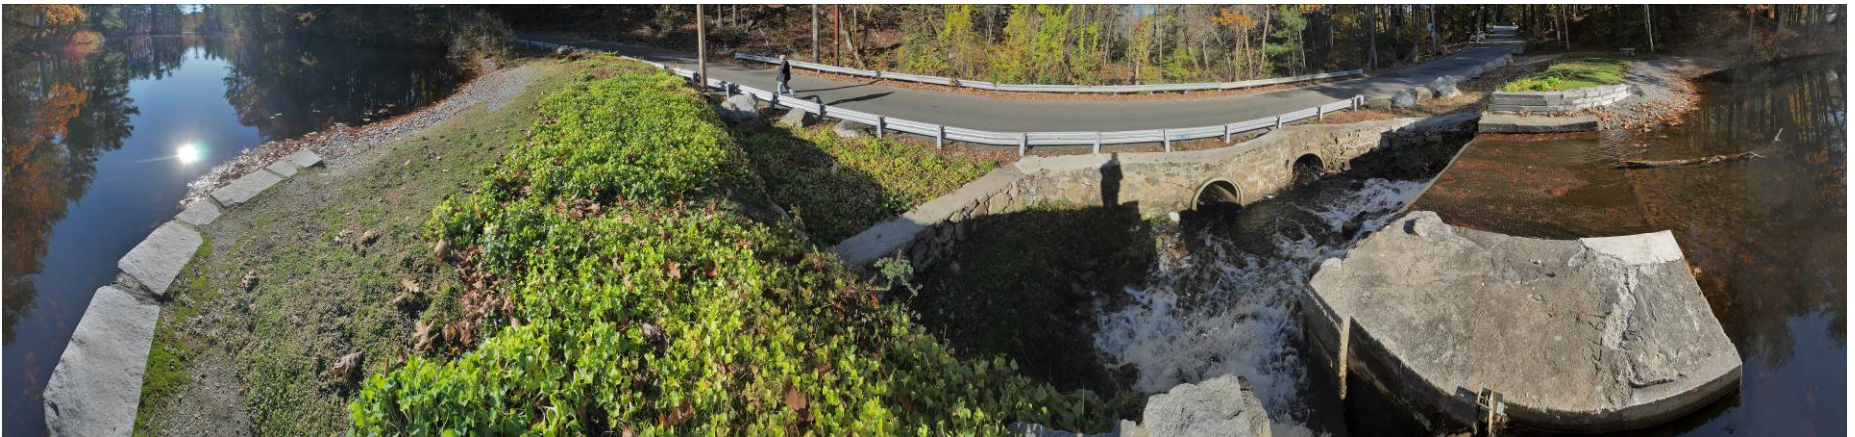
Photo 6 – View downstream from dam crest, including embankments, spillway, plunge pool, Rattlesnake Road*

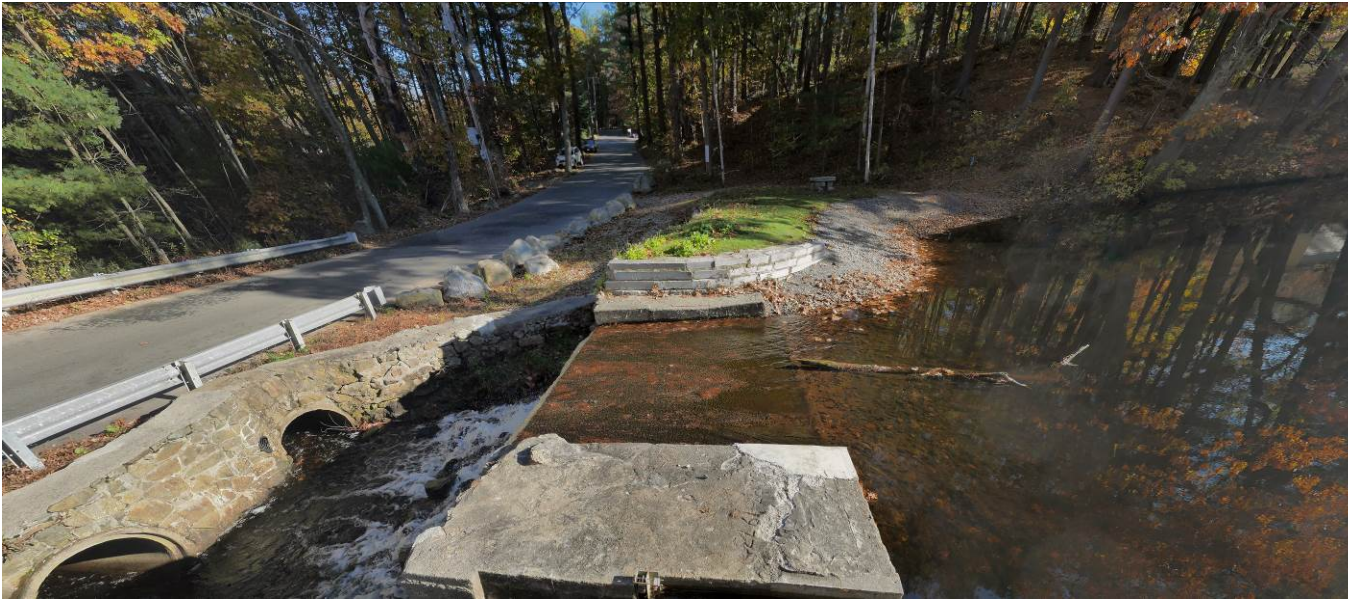
Photo 7 – Right embankment, spillway, and plunge pool from crest*

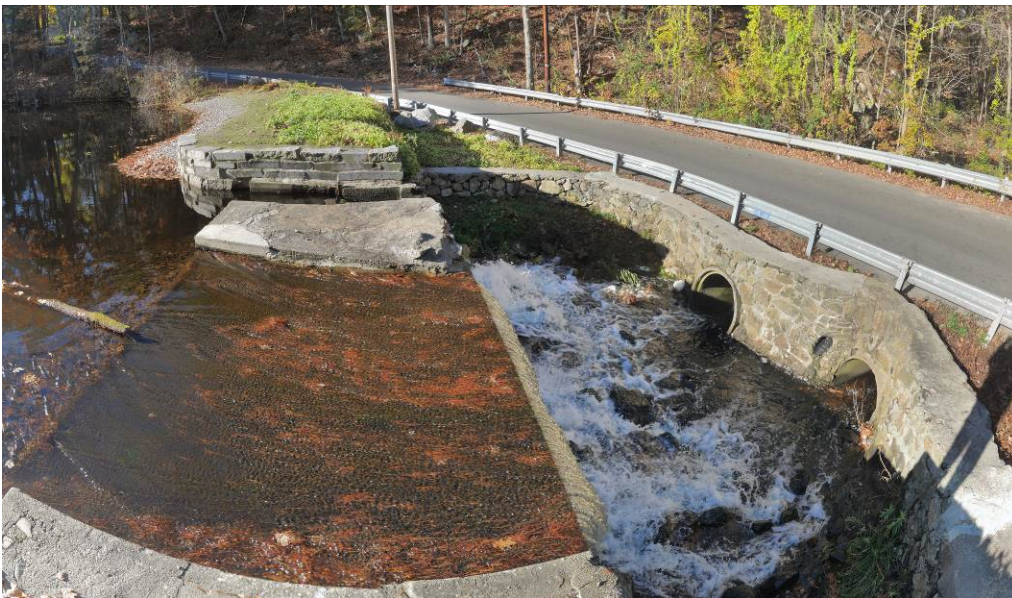
Photo 8 – Left embankment, spillway, sluiceway, and plunge pool from crest*

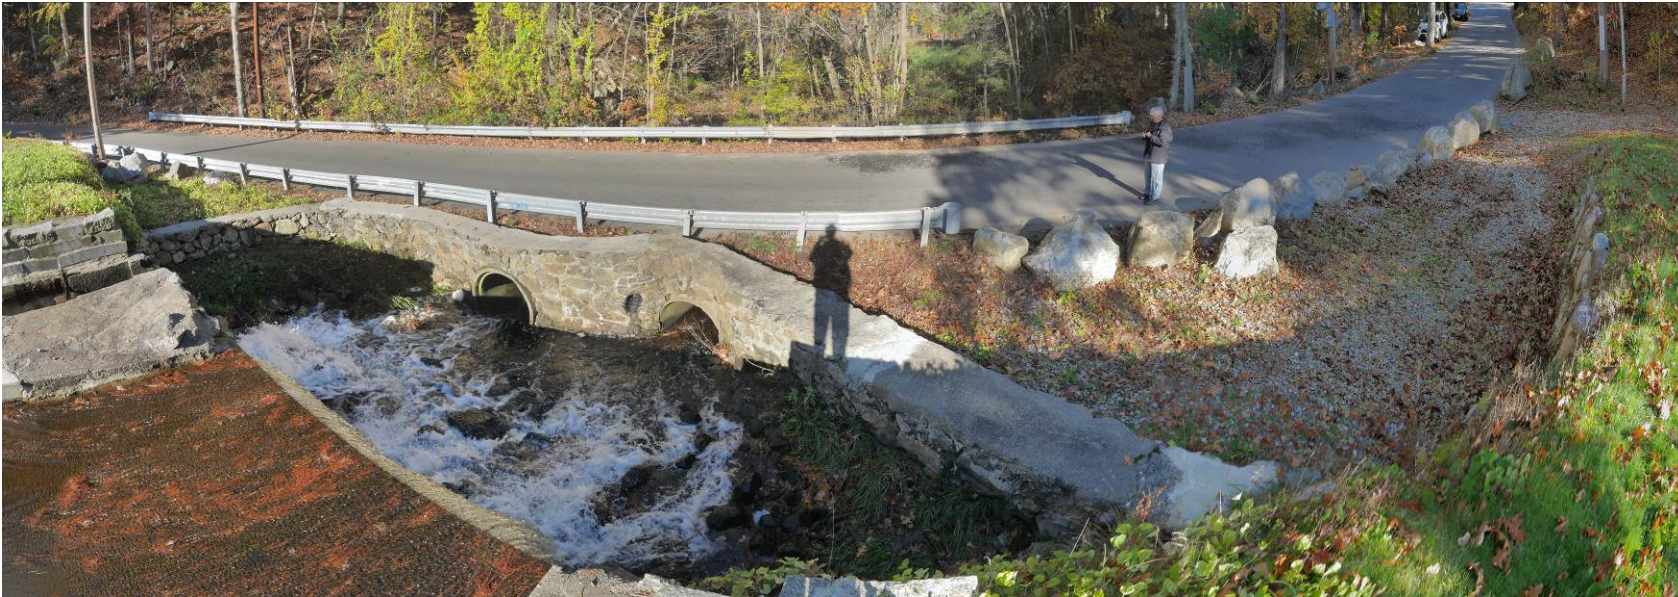
Photo 9 – Spillway, plunge pool, and downstream from right crest*

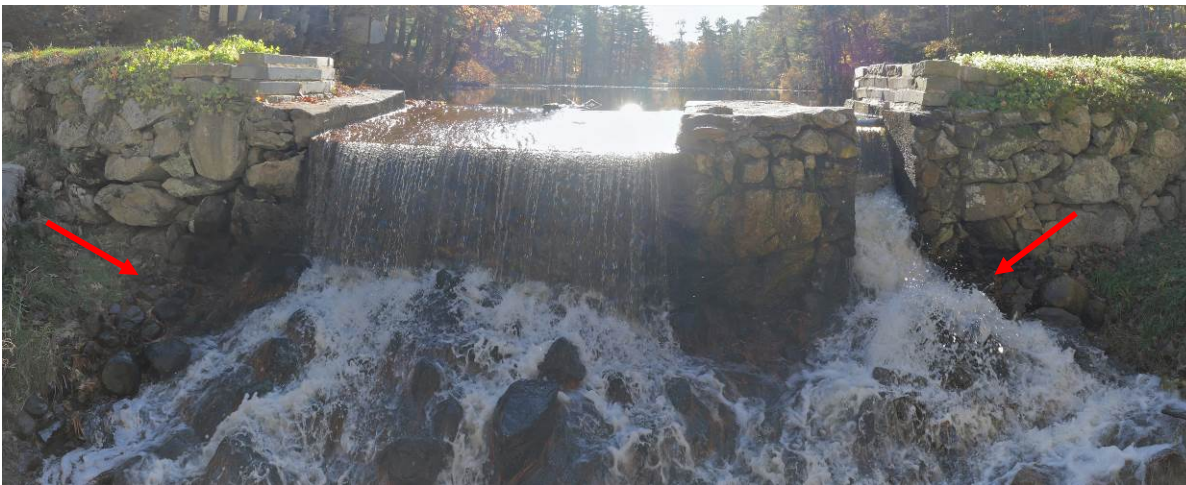
The downstream face of the dam consists of a masonry stone wall with an irregular profile. The masonry is largely unmortared except for below the spillway. We noted slight seepage flows (~0.5 gallons/minute [gpm]) on at the toe of the stone masonry wall on both sides of the spillway. The seepage appeared to be clear.

Photo 10 (left) – Spillway and sluiceway from downstream (arrows show general seepage sites)*

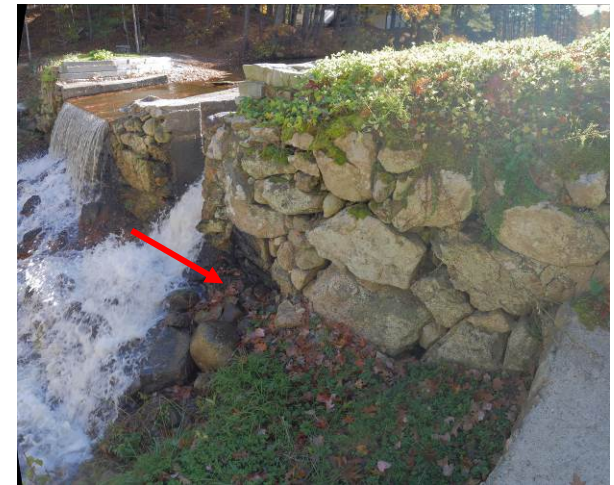
Photo 11 (right) – Right downstream embankment wall at spillway (arrows show general seepage site)*

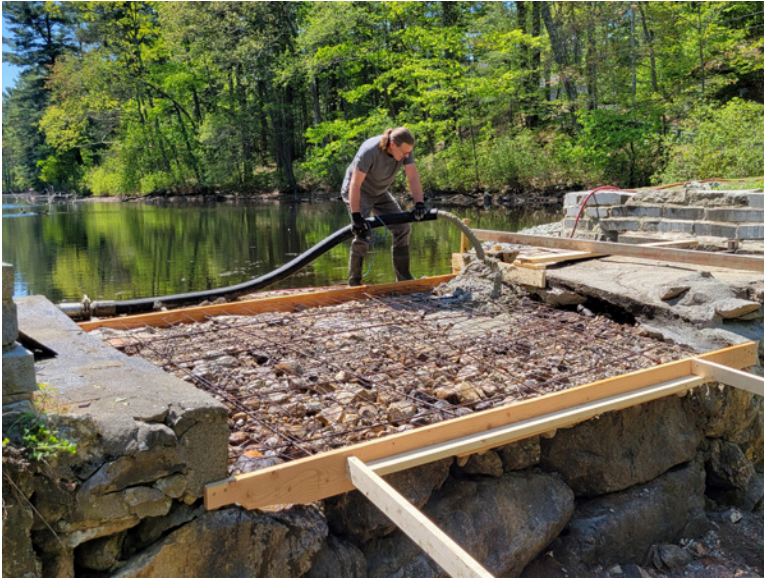
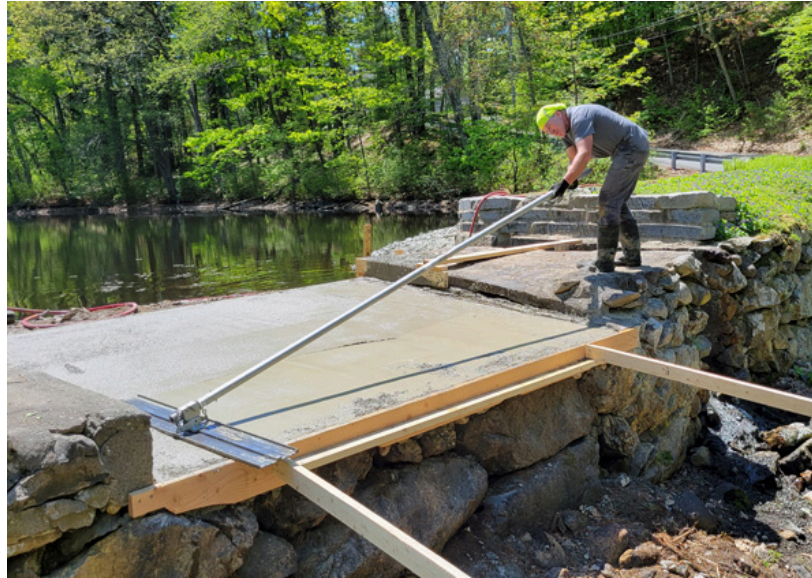
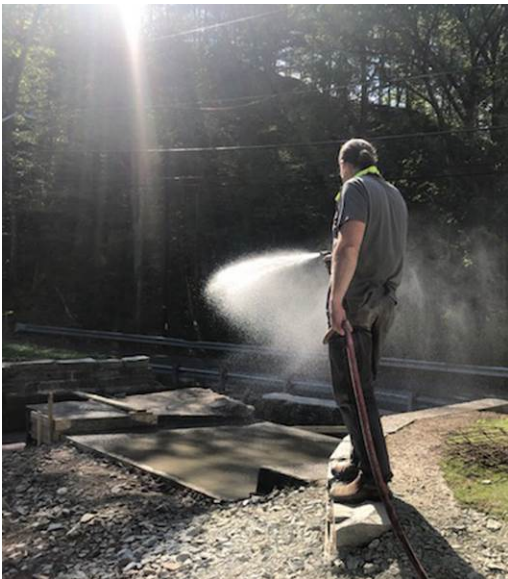
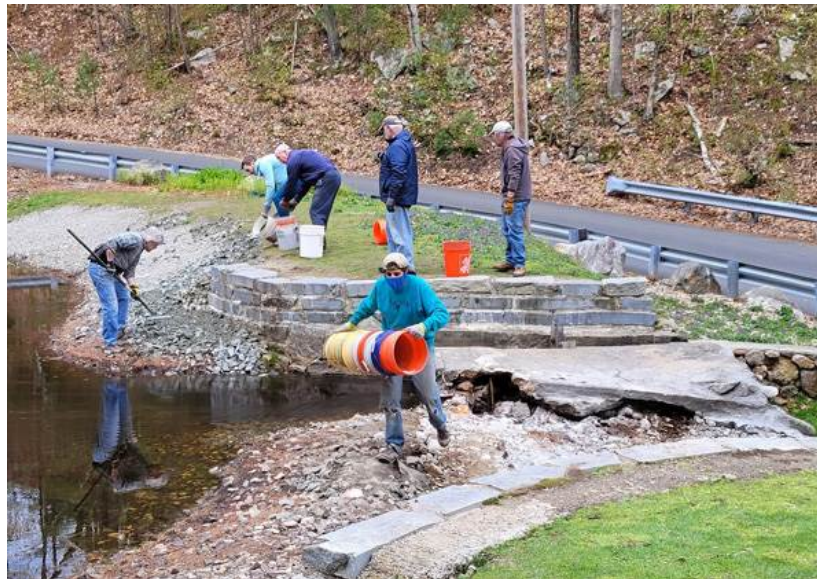
In May 2021, the FPC undertook additional maintenance activities. The remedial maintenance included replacement of the reinforced (welded-wire) spillway crest slab and placement of 15 tons of crushed stone on the upstream slope and 6.5 tons of river stone on the auxiliary spillway as erosion protection. The new spillway slab replaced a cracked and unreinforced concrete slab and required 3.5 cubic yards of concrete. Photos from the FPC website of the work are included in Appendix A as Photos 12, 13, 14, and 15.

Photos 12 (upper left), 13 (upper right), 14 (lower left), 15 (lower right) – May 2021 maintenance activities – replacing spillway slab (12, 13, 14) and placement of additional gravel on upstream slope (15). Gravel also placed over auxiliary spillway. Photos from Foster's Pond Corporation website.
