2011 Project Completion Report Invasive Aquatic Plant Management Program at Foster's Pond Andover, Massachusetts

Report Prepared by: Aquatic Control Technology, Inc.

Report Prepared for: Foster's Pond Corporation

December 20, 2011

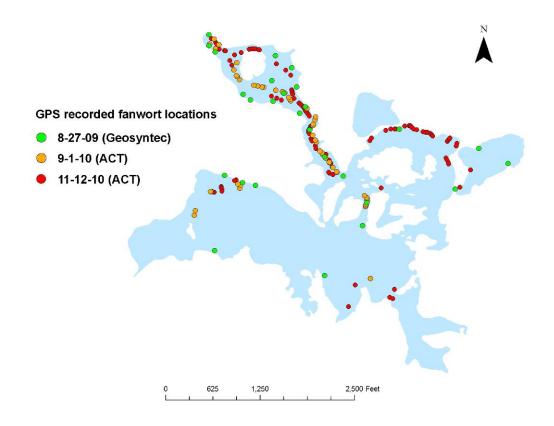
In 2010, Aquatic Control surveyed Foster's Pond on September 1st and November 12th. During both surveys the entire water body was toured and aquatic vegetation was identified and spatially referenced. A handheld GPS was used to mark locations of fanwort. Approximate locations of Fanwort recorded by Geosyntec in 2009 and Aquatic Control in 2010 are depicted in the map below.

Fanwort was found in moderate to abundant densities throughout the Outlet Cove, the Channel and the northwestern portions of Mill Reservoir. Some isolated fanwort plants were found along the edges and at the opening of the dredged eastern basin of Mill Reservoir. Fanwort growth in the Main Pond was confined to the edges of dense waterlily beds found along the western and southern shorelines. No fanwort was found in deeper water areas towards the middle of Main Pond or in the shallow southwest and southeast coves that support nearly 100% waterlily cover. Fanwort plants in the northern half of the pond were robust and were not showing any signs of senescence even during the November 12th survey.

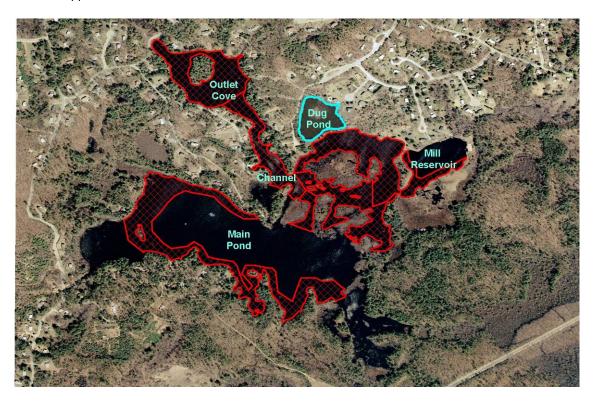
During the winter of 2010/2011 a treatment plan was developed for Foster's Pond and Dug Pond. A combination treatment using SonarOne, a time-release pellet, and Sonar A.S. liquid was recommended for Foster's Pond. The use of the pellets would allowed for the treatment program to be initiated earlier in the growing season when the fanwort plants were more susceptible and allowed for the herbicide to be targeted in the infested areas. This approach reduced the total amount of herbicide required, reduced the number of herbicide applications that were needed and reduced the treatment program cost. The areas with red hatching below are where the SonarOne pellets were applied.

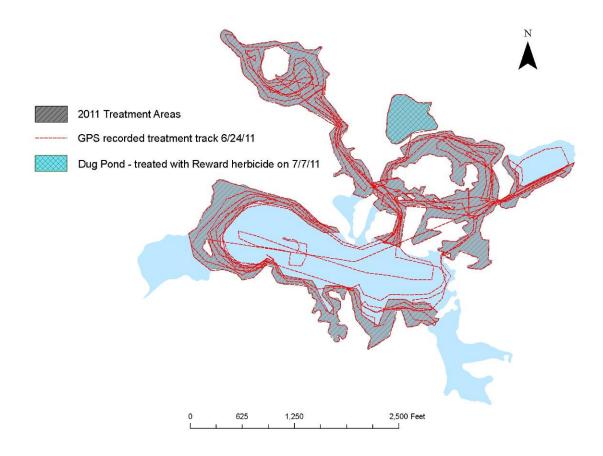
GPS was used during each application to insure an even application through the treatment area. A map depicting GPS track recorded during the treatment on 6/24/11 follows:

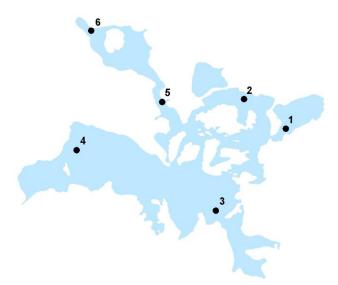
• FasTEST sample locations

Water samples from Foster's Pond were collected for FasTEST immunoassay analysis of remaining fluridone residues. Samples were collected on three occasions during the course of the treatment program to help assist in the timing and dosing of subsequent Sonar applications and ensure that sufficient fluridone concentrations were maintained in the pond for a minimum of 60 days. FasTEST samples were collected by ACT, Inc. and shipped to the SePRO Laboratory in Whitakers North Carolinian via overnight carrier for analysis. Results of the FasTEST sampling performed at Foster's Pond in 2011 are listed below. Laboratory reports from SePRO are attached.

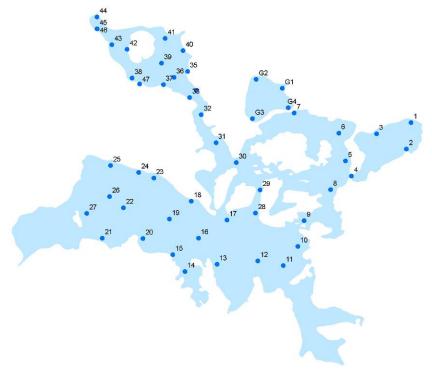
Data point locations (established 2004)

A post-treatment survey of Foster's Pond was conducted on September 19, 2011 to document post-treatment aquatic plant composition and distribution. The survey methodology used was consistent with surveys performed in 2004, 2005, 2008 and 2009 and utilized the same transects and data points established in 2004. In total 50 data points were surveyed. A map depicting transect and data point locations follows; the data collected on 9/19/11 is attached to this report.

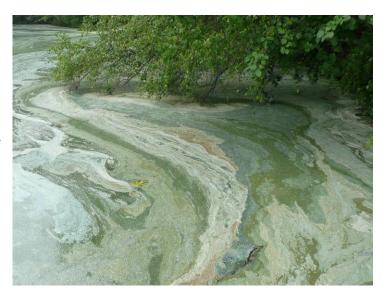
There was also a microscopic algal bloom reported by FPC early August. Algal blooms are usually fueled by excessive nutrients and favorable weather conditions. Algal bloom conditions have developed in prior summers, but the surface "scum" of decomposing algal cells reportedly has not occurred. The surface scum was broken-up by heavy rainfall and wind and disappeared after a couple of weeks. No surface algal scum was observed during the post-treatment survey on September 19th.

The Sonar herbicide treatment may have partially contributed to the bloom conditions that developed in 2011, but this was not observed following prior treatments at Foster's Pond. Algae blooms following Sonar

herbicide treatments are uncommon; because Sonar works so slowly that the plants do not decompose and release a "slug" of nutrients into the waterbody. However, if the aquatic plants were not actively utilizing available nutrients due to impacts from the Sonar treatment, then the algae may have been able to capitalize on available nutrients.

The fact that there was an algal bloom suggests that there is excessive nutrient loading at Foster's Pond. Abnormally low water levels in Foster's Pond over the past two years – intentional lowering for dam repairs followed by drought-like conditions – may have impacted water quality, but there are no data available to validate these suspicions. Comprehensive water quality monitoring should be considered in future years to help determine if the nutrient loading is being caused by external (watershed runoff) or internal (bottom sediment and decomposing plants) sources.
