After Action Report Foster's Pond, 2020

Summary

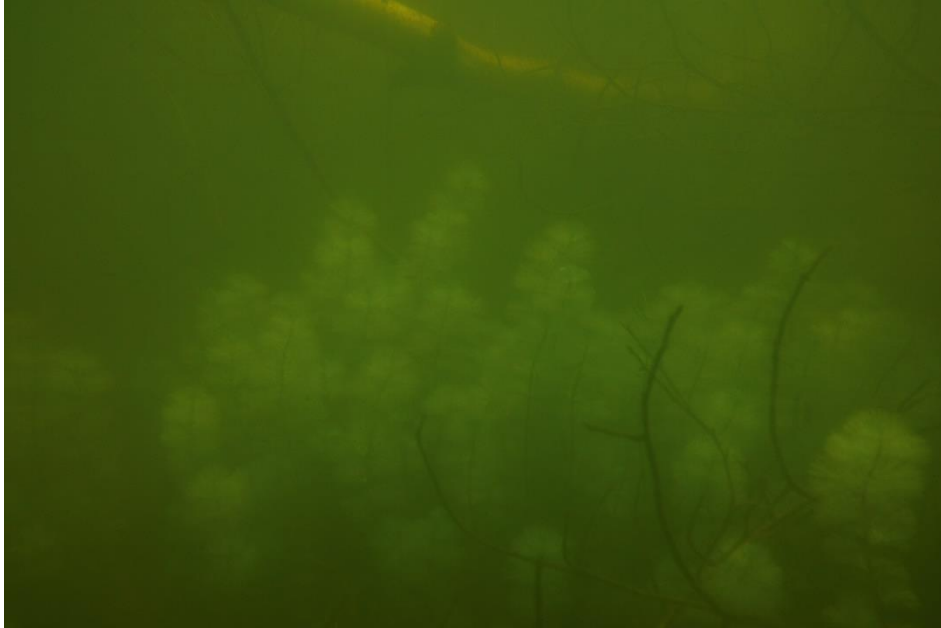
Dug pond accounted for approximately 30% of the biomass removed. Only a few fragments were removed from Area 5 just south of Dug. We began by removing a large patch on the western shore.

Image 1: A portion of the large patch near the downed tree for scale. Water conditions made capturing an image of the entire patch impractical.

Due to its size and density, a floating barrier was deployed around the patch to reduce fragmentation.

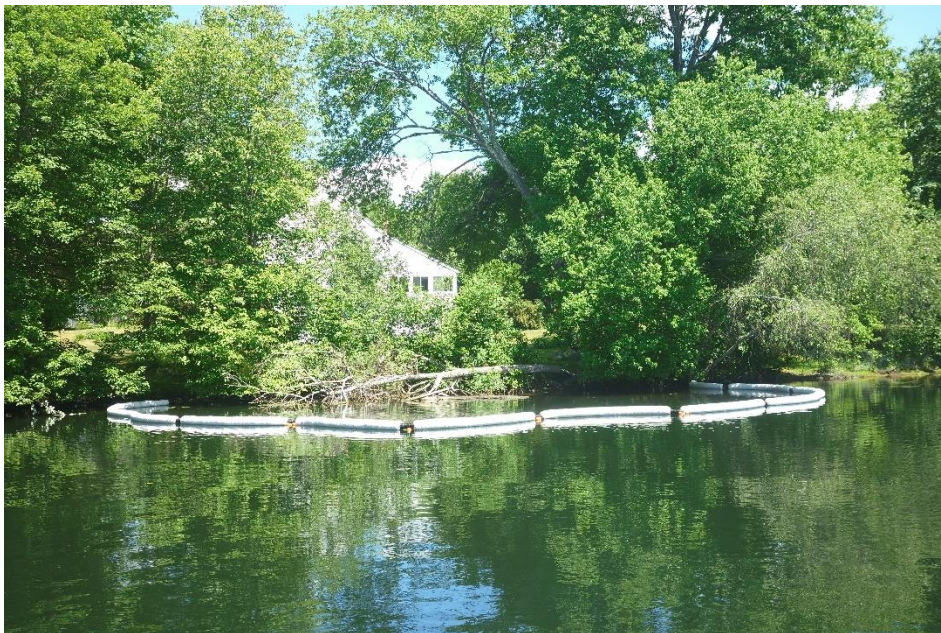
Image 2: The floating barrier around the initial patch.

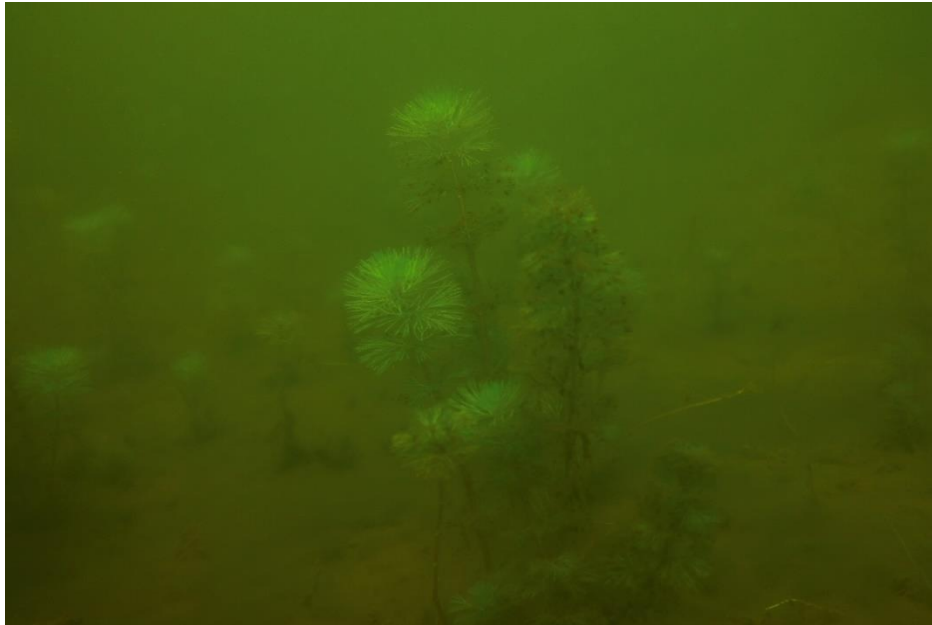
We then searched the entire littoral zone from the shore to the persistent thermocline at a depth of roughly 10 ft. Other than the initial patch, the Fanwort was mostly sporadic small to medium sized plants. Though a few small patches were revealed, including one beneath the thermocline at approximately 15 ft. The search also revealed that the removal site from the 2019 season remains clear, with the exception of a few small plants on the border of the previous target area.

Image 3: A small Fanwort plant in the patch below the thermocline.

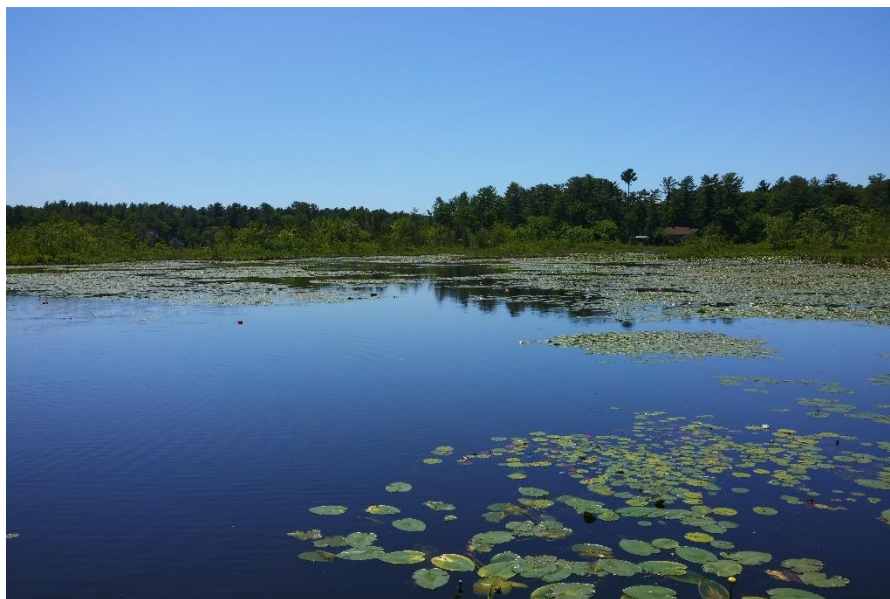
This area accounted for roughly another 30% of the removed biomass. We searched the area in a grid pattern removing sporadic small and medium sized plants throughout, as well as the occasional small patch.

Image 4: The Mill Reservoir entrance with orange survey buoys visible.

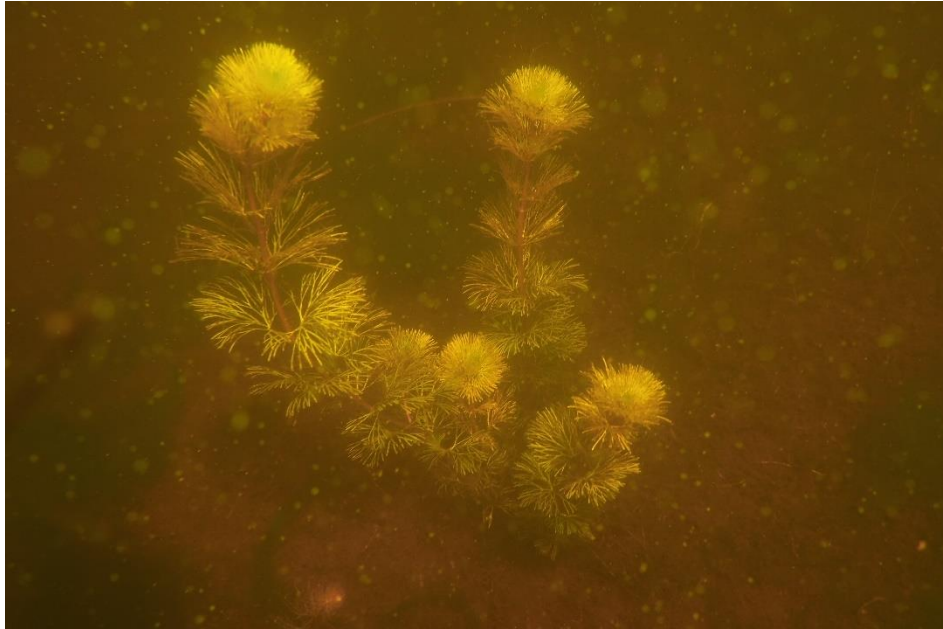
Many of the plants, especially those nearest the entrance to the reservoir, exhibited significant chlorosis.

Image 5: A Chlorotic Fanwort plant in the Mill Reservoir Entrance.

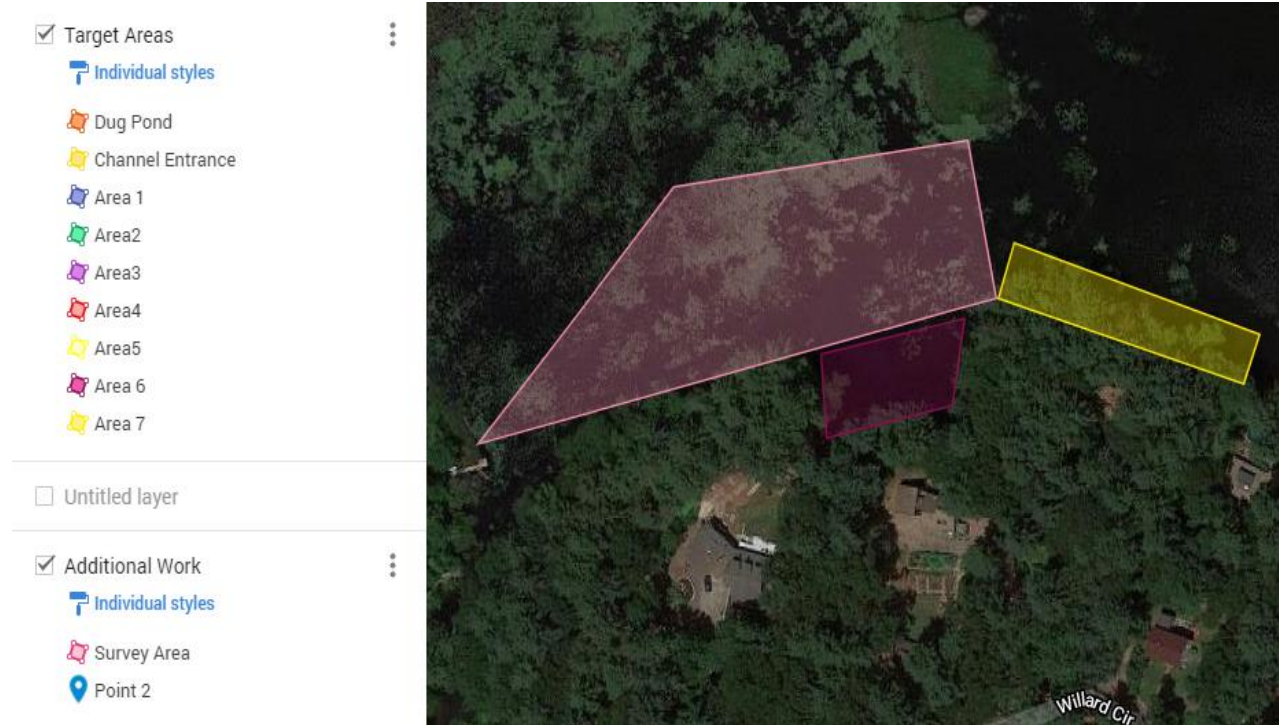
Map 2

These areas were targeted based on a report from a resident and accounted for the remaining 30% of removed biomass. In addition to the plants removed from Areas 6 and 7, a survey revealed a significant amount of patchy surfacing Fanwort to the North.

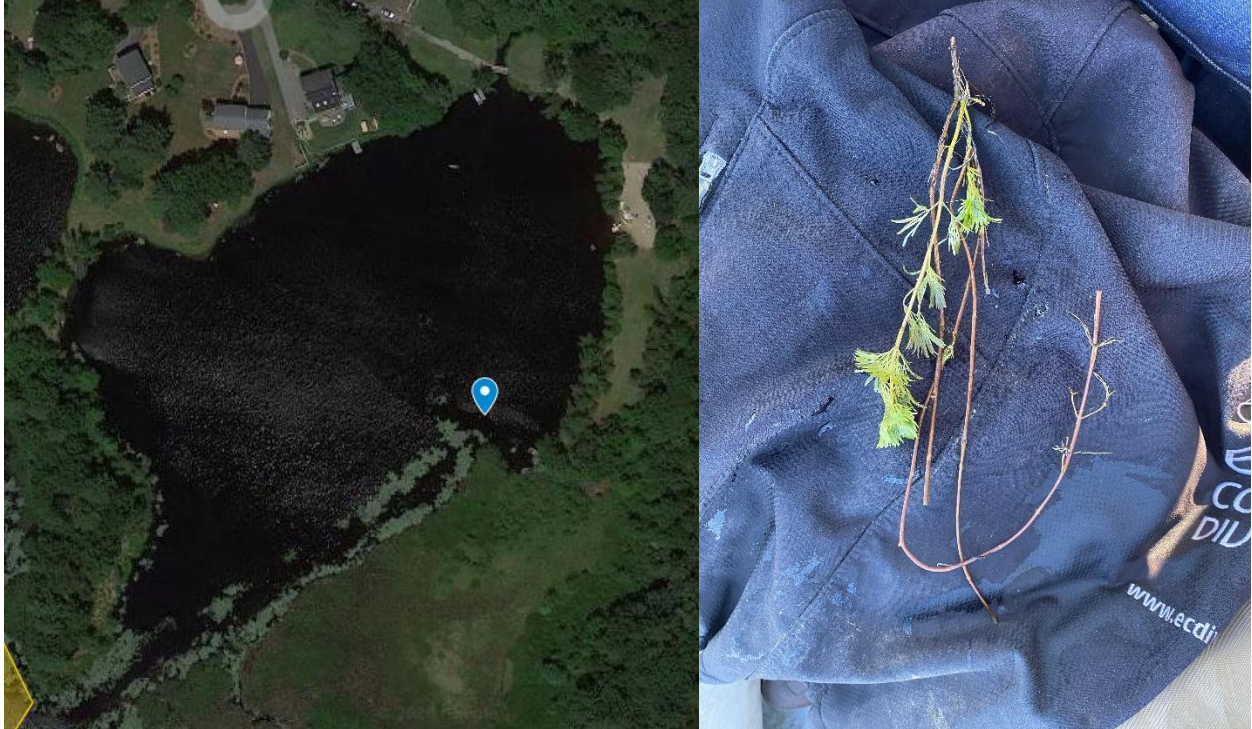
Despite being cut short by an unplanned dive, a brief survey within the Mill Reservoir revealed traces of Fanwort at the point indicated in the map below. Most appeared to be dead or dying, but some new growth was observed that did not seem to be affected by the chemical treatment. Additionally, a significant number of surfacing plants were observed in the area north of Areas 6 and 7. This growth did not appear on previous survey maps and could be indicative of a wider infestation along the northwest shore of the main pond.

Image 8: The location in Mill Reservoir where Fanwort fragments were found.
