FOSTERS POND DAM
PHASE I
INSPECTION / EVALUATION REPORT

Dam Name: Fosters Pond Dam
State Dam ID#: 5-5-9-10
NID ID#: MA00153
Owner: Foster's Pond Corporation
Owner Type: Private
Town: Andover, Massachusetts
Consultant: GEI Consultants, Inc.
Date of Inspection: November 10, 2006

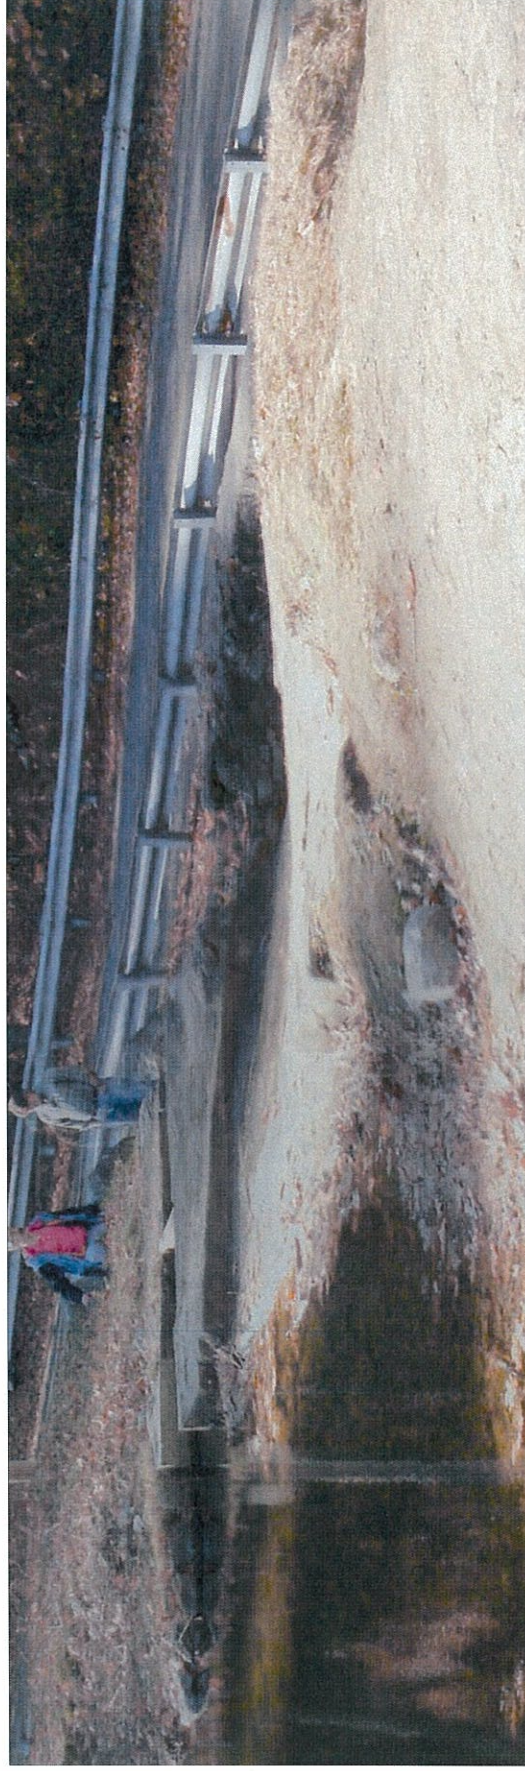
Photo 10 – Panoramic composite – Spillway from right upstream*

The upstream face of the embankment was mostly underwater. Visible portions showed intermittent riprap slope protection: however, riprap was missing in places, probably by wave action, erosion from previous overtopping events and/or pedestrians (Photo 18). Riprap was not observed on or near the slope leading to the main spillway. An erosion gully caused by dam overtopping in May 2006 was noted to the right side of the main spillway (Photo 14). A sinkhole was also noted at the upstream edge of the erosion gully. An area of erosion caused by foot and canoe traffic at water's edge was noted further to the right of the main spillway (Photo 3).

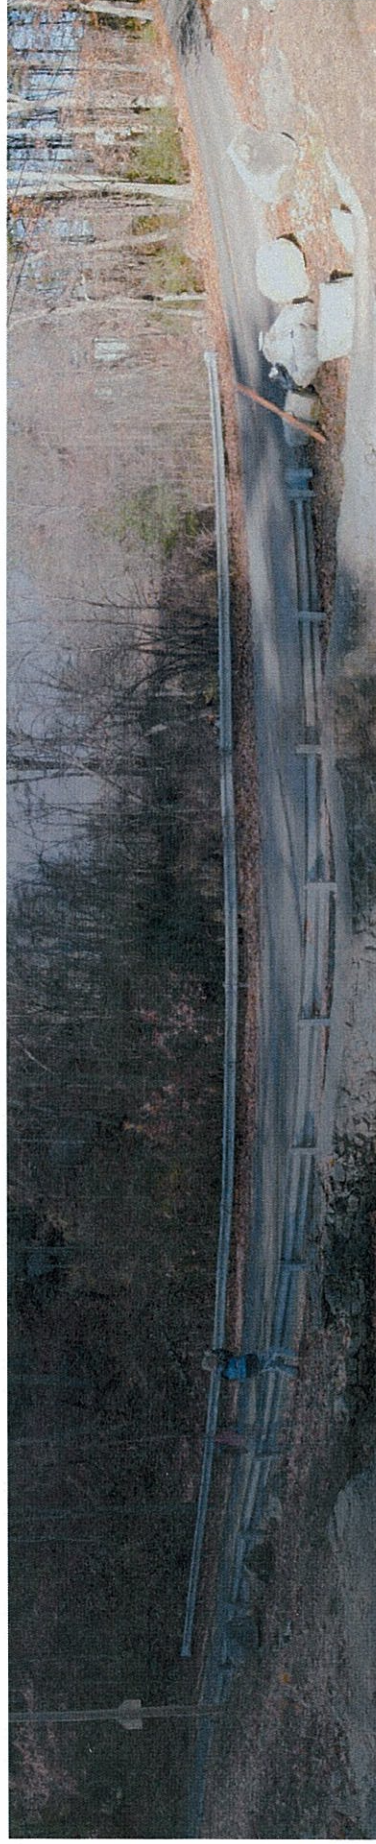
Photo 17 – Panoramic composite – Downstream roadway (Rattlesnake Hill Road) and wetland*

Rattlesnake Hill Road is located approximately 20 feet downstream of the dam (Photos 1, 2, 3, 4, 7, 8, 10 and 11). Flow from the primary spillway and the sluiceway passes under Rattlesnake Hill Road through two 42-inch diameter concrete pipe culverts (Photos 7 and 11). Downstream of Rattlesnake Hill Road, water flows through wooded wetlands towards Woburn Street (Photo 21) and eventually flows into the Shawsheen River upstream of the Ballardvale Dam.

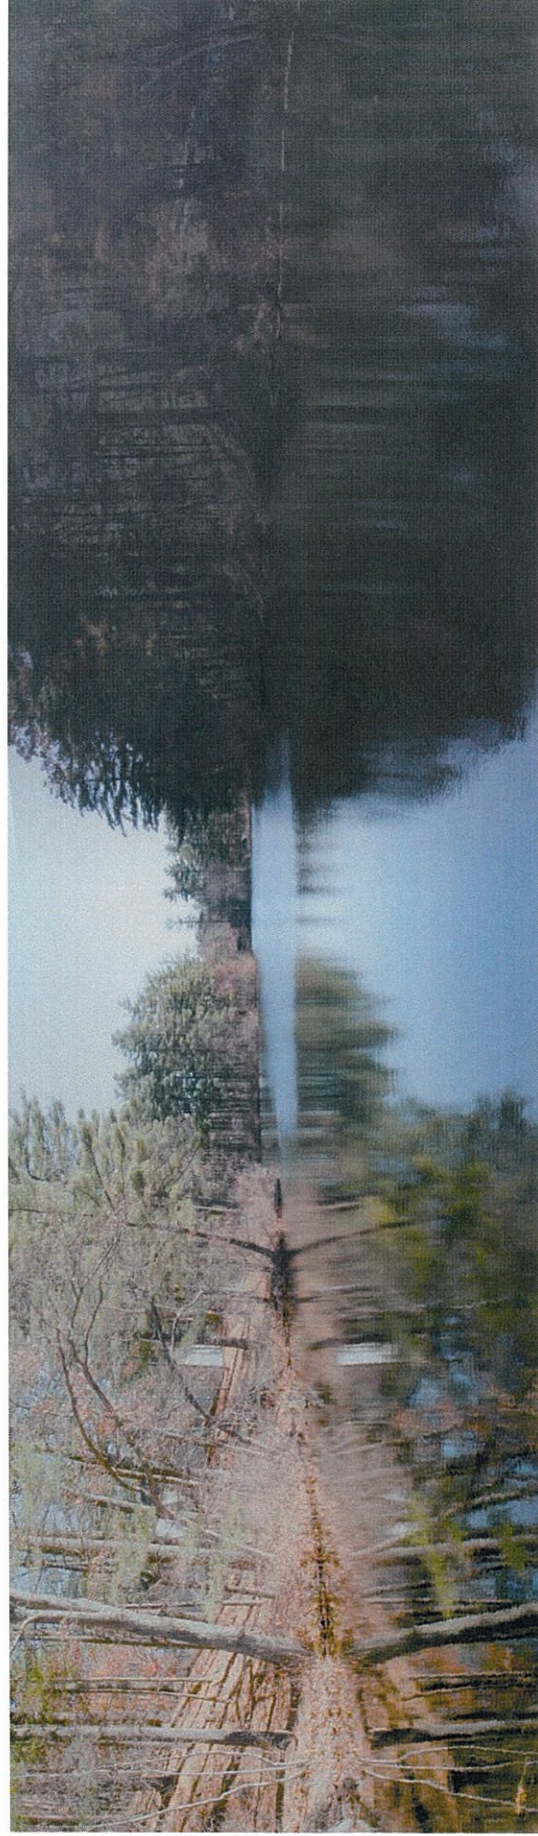
Photo 20 - Panoramic composite – Foster's Pond from dam*

Fosters Pond orientation is shown in Fig. 1. The impoundment is located within a primarily suburban area with private homes located along the shoreline. The shoreline is primarily wooded with generally gentle to moderate slopes around the pond perimeter (Photo 20). The slopes along portions of the west side of the impoundment are hilly.
